Signet Home Inspections, LLC

Comprehensive Property Inspection Report

1001 Scenic Lane, Small Town, CA 12123
Inspection prepared for: Jack & Diane Buyer
Real Estate Agent: Great Agent - All American Real Estate Company

Date of Inspection: 8/1/2019 Time: 9:00 AM

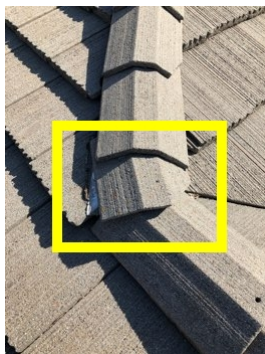
1.1. **NOTE:** Roof hump and/or dip noted which can be caused from a rafter board that has warped over time, has been pushed up by additional bracing or is the result of newer construction. Inspector did note **questionable construction** in attic (see: "Attic > Structure") and therefore could not determine structural significance of hump and/or dip. Since this is only a visual inspection and DOES NOT constitute a certification of structural integrity or lack thereof, if in doubt consider having a qualified professional evaluate the integrity of the structure.

Rear roof waviness

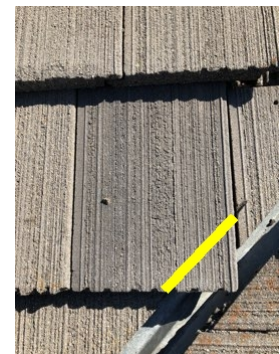
1.4. One or more roof tiles were found to be out of place. Recommend a qualified roofing contractor check for others and reposition/secure as needed.

Loose valley tile

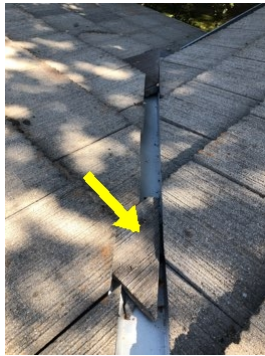
New tile not cut for valley flashing

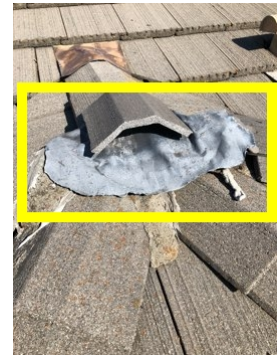
Patched right side tile

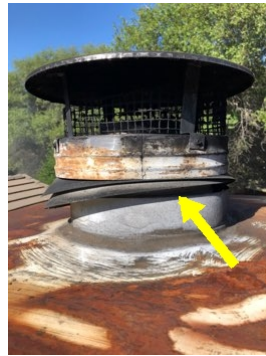
4.2. Chimney flue collar noted as loose. Recommend fastening as needed.

Loose chimney flue collar

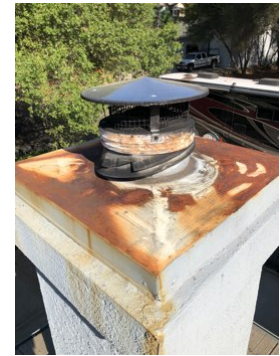
4.1. Metal chimney crown rust noted. Recommend prepping and sealing with a rust-inhibiting paint as needed.

Rusted metal chimney crown

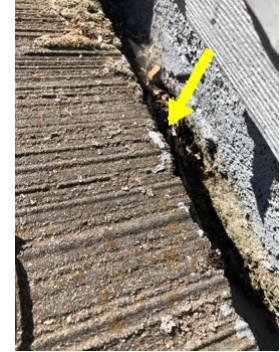
4.5. Clogged flashing noted. Recommend clearing debris, checking for integrity and if necessary, either prepping and painting with a rust-resistant paint or replacing as needed.

Clogged chimney 2 upper flashing

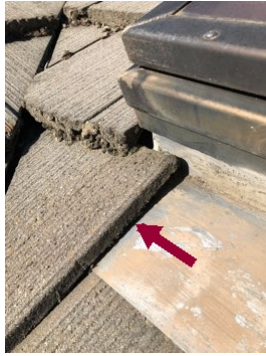
6.1. Roof tile noted over bottom flashing (which should be under) restricting path of rain water and increasing chances of leaking. Recommend consulting with a qualified roofing contractor for remediation options.

Skylight flashing under tile

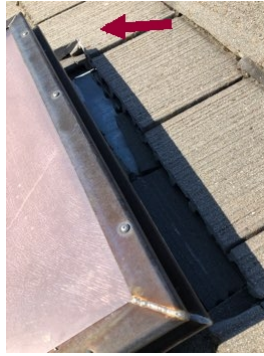
Loose tile above skylight

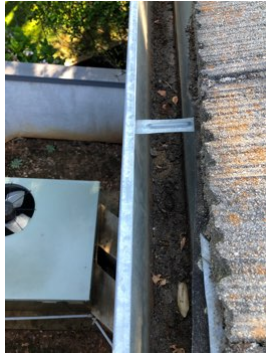
7.1. Gutters with organic materials were noted. Recommend cleaning to avoid downspout clogging and premature gutter deterioration. Consider adding gutter screens to avoid future problems.

Organic material in gutter

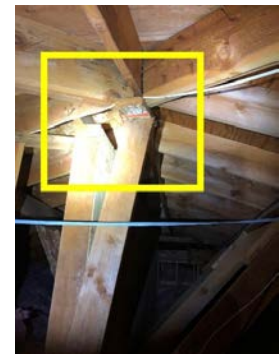
2.3. Questionable construction noted in the form of additional bracing and because of its structural significance considering the weight of a tile roof, this type of work would require a knowledge of load capacities, approved plans and final inspection sign-offs. Recommend checking with seller for such and if necessary, consulting a qualified contractor or structural engineer for further review.

Questionable rafter support

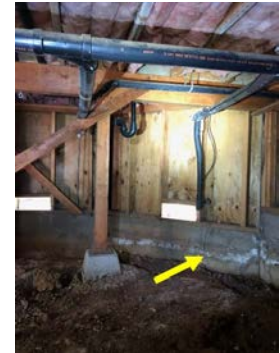
3.1. **Efflorescence** was noted on foundation walls which would indicate water intrusion to some degree. Recommend all Home Inspection Report measures to channel water away from foundation (see notations under: "Grounds > Grading").

Efflorescence on foundation wall

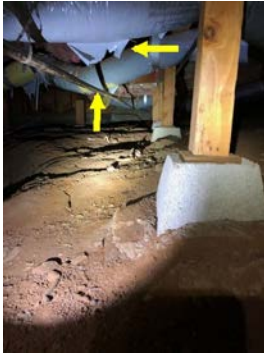
12.2. The vapor barrier on some ducting was noted as torn or missing. Recommend repair as needed.

Torn duct pipe vapor barrier

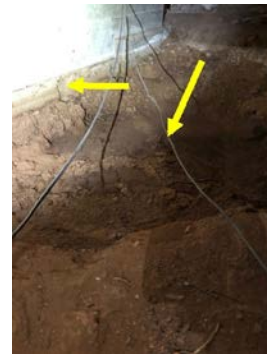
14.2. A large pit noted in rear right crawlspace section with foundation wall footing possibly cracked and exposed from erosion. Evidence of past **ponding** noted in area as well. Recommend checking with seller for further details.

Large pit/exposed footing crack rear right

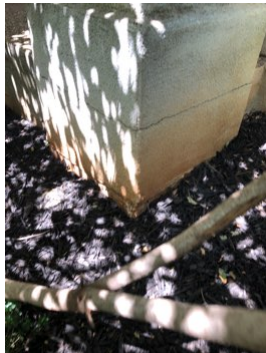
Left column bottom cracking

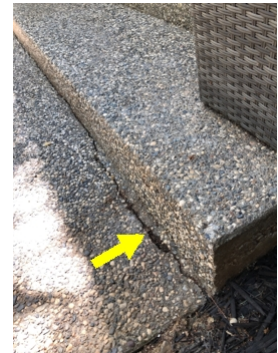
Concrete entry stair base cracking

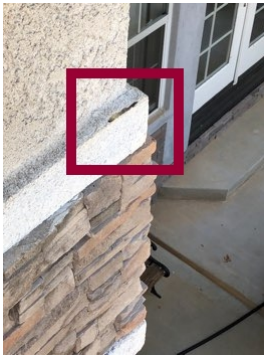
- 4.1. **Exposed EPS** (encapsulated polystyrene) foam was noted on rear trim. Although durable and resistant to decay, EPS foam is a soft material susceptible to insect intrusion and should not be left exposed. Recommend sealing as needed.
- 4.2. EPS (encapsulated polystyrene) foam junction cracks were noted. Although EPS is durable and resistant to decay, these cracks can allow moisture to reach the wood wall sheathing which is not resistant to decay. Recommend sealing as needed.

Exposed foam above rear right column

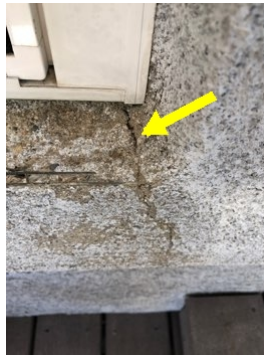
Rear right window trim cracking

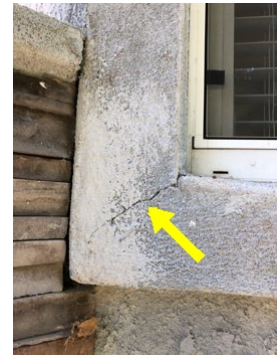
Window trim cracking

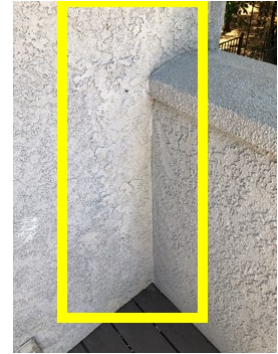
Stucco patch on master deck area

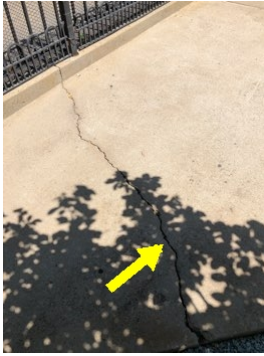
13.1. Moderate cracking was observed in concrete. Further deterioration will occur as water expands and contracts

Right side patio cracking

from freeze and thaw cycles and some may become trip hazards as well. Recommend sealing the cracks, continued monitoring and consulting a qualified contractor for remediation options should condition worsen.

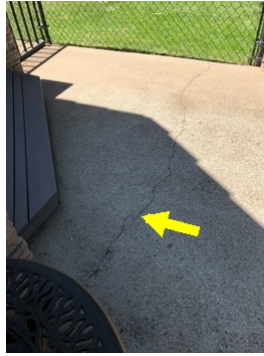
Right side patio cracking

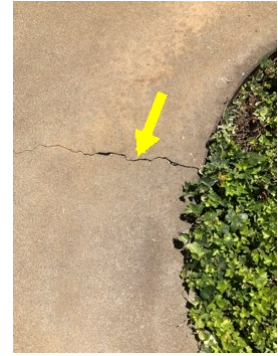
Rear patio cracking

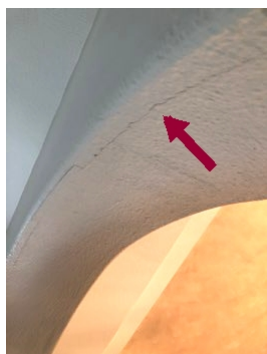
4.1. **Sheetrock crack(s)** noted which normally represents a cosmetic issue as opposed to a structural problem. Consider patching with a flexible caulking to reduce or eliminate eyesore.

Dining archway cracking

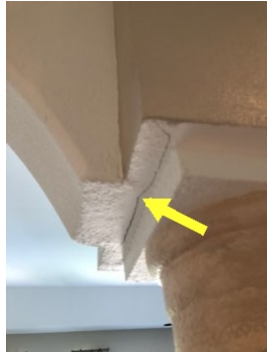
Left living room column crack

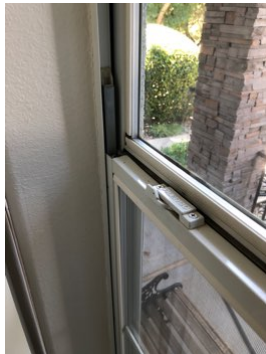
9.3. Broken or weak **balance springs** noted on window(s). Recommend replacement as needed.

Living room window broken balance spring

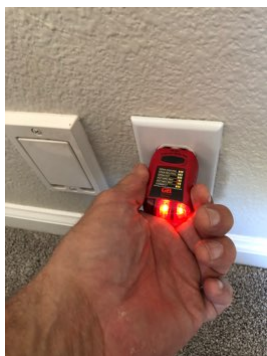
13.1. One or more wall outlet(s) noted to be loose inside box which could loosen wires and cause arcing. Recommend a qualified electrician check for loose wires and tighten as needed.

Loose living room outlet

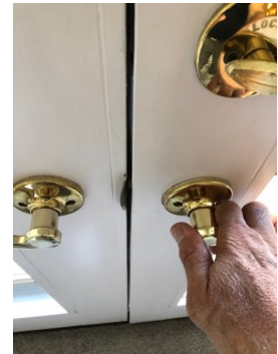
Deficient door latch

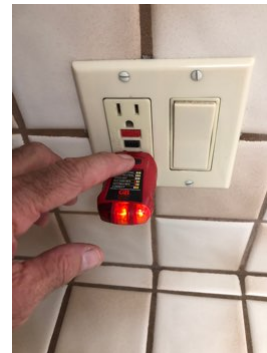
Deficient counter GFCI outlet

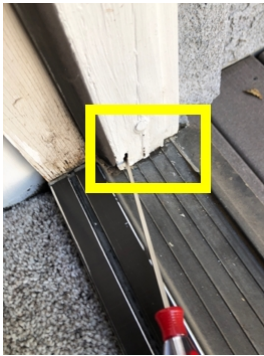
14.1. Lower door jamb wood decay noted. Refer to pest report for more detail and consider consulting a qualified contractor for remediation options.

Door jamb wood decay

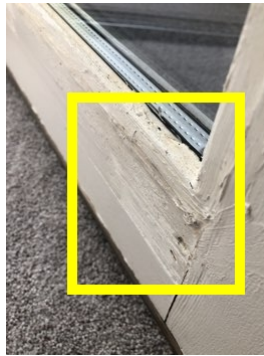
Door frame damage

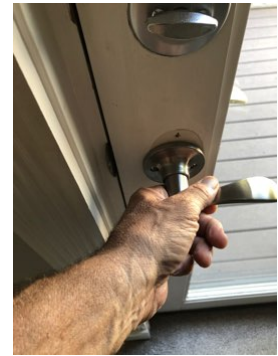
14.2. Door would not latch closed. Recommend repair as needed.

Deficient door latch

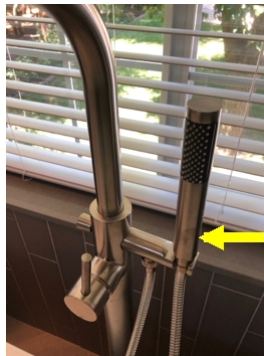
7.3. NOTE: Tub spray wand could not be turned on for reasons unknown. Recommend checking with seller for further detail.

Spray wand not tested

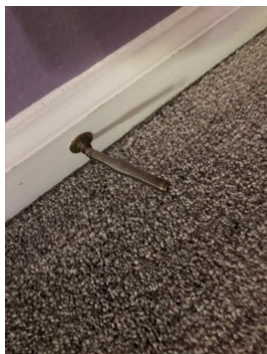
2.1. Missing, poorly adjusted or damaged door stop noted which serves to protect wall or other surfaces from damage. Recommend adding, adjusting or replacing as needed.

Deficient bedroom 3 door stop

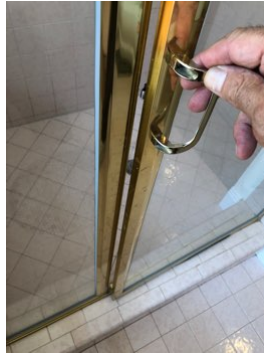
7.1. Bath 2 glass shower door was sticking at bottom and difficult to close. Recommend repairs as needed.

Bath 2 shower door rubs at bottom

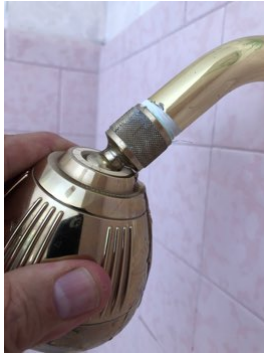
10.1. Shower head and/or hose noted to be leaking. Recommend repair as needed.

Leaking bath 2 shower head

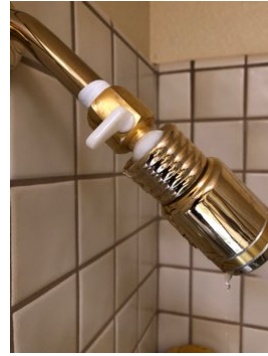
Leaking bath 3 shower head

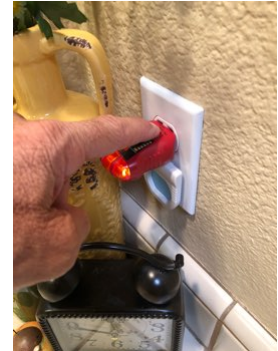
Deficient bath 3 GFCI outlet

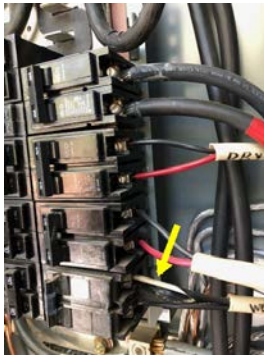
7.1. Unmarked **white wire** used as hot conductor which is not an appropriate and would be considered unsafe to someone working on the electrical system of this house. Recommend re-identification to black or red as needed for safety.

Unmarked white wire in main breaker box

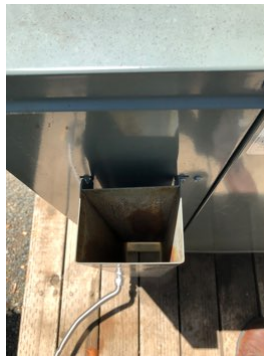
7.1. Exterior HVAC unit exhaust vent noted to be missing screen which could allow for vermin intrusion. Recommend adding an appropriate screen as needed.

Missing exterior vent screen

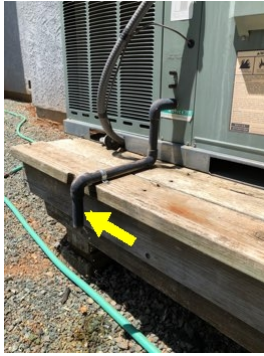
10.1. Condensate drain line water trap noted to be broken, deficient or missing. Recommend repairs or replacement as needed by a qualified HVAC contractor.

Missing trap on condensate drain line

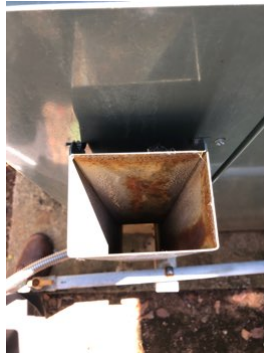
7.1. Exterior HVAC unit exhaust vent noted to be missing screen which could allow for vermin intrusion. Recommend adding an appropriate screen as needed.

No exterior vent screen

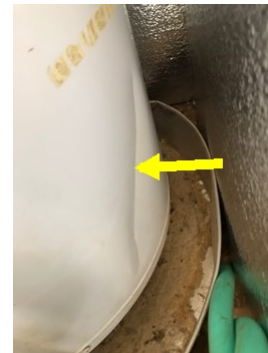
Outer shell damage

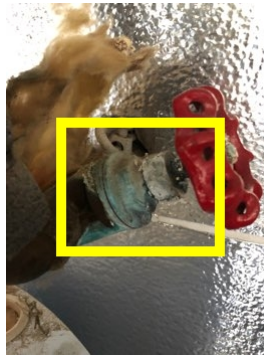
10.1. Water shut-off valve noted as corroded and at risk of, or leaking. Recommend repairs by a qualified plumber as needed.

Corroded water shut-off valve

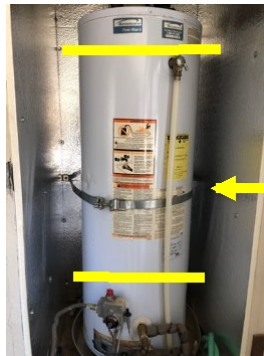
11.1. **water heater strapping** is not to code which requires two straps 1/3 from both top and bottom. Recommend proper strapping as needed for safety.

Deficient strapping

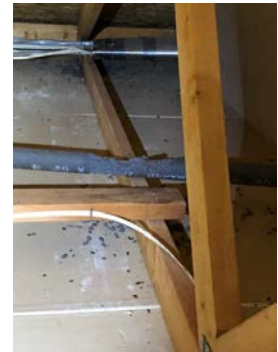
Pipe insulation rodent damage

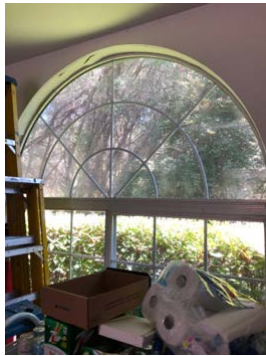
4.1. Fog and/or condensation or the resulting stains were noted in double-pane window(s) which is an indication of a failed seal. Recommend review for repair or replacement as necessary.

Possible failed seal

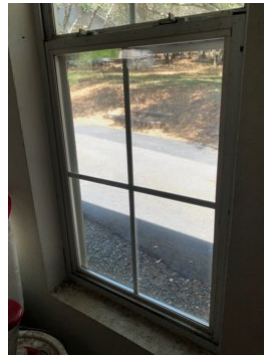
4.2. Broken or weak balance springs noted on window(s). Recommend replacement as needed.

Broken balance spring

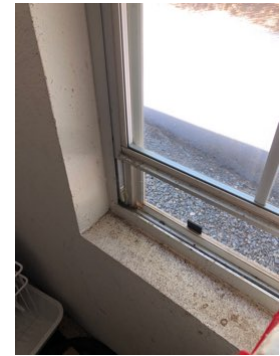
Broken balance spring

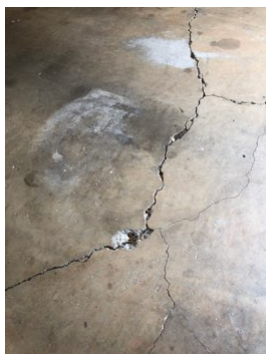
6.1. Large crack(s) noted in concrete garage floor. Recommend sealing, continued monitoring and consulting a qualified contractor for remediation options should conditions dramatically change.

Significant concrete floor cracking

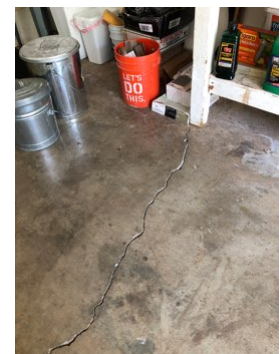
Significant concrete floor cracking

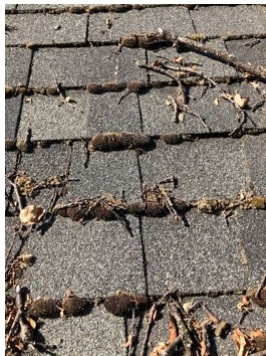
1.1. **Moss on composition** roof noted which can lead to the premature failure of the roof and subsequent leaks. Recommend treating moss during its growing season (wet months) with a moss killer.

Moss on shingle roof

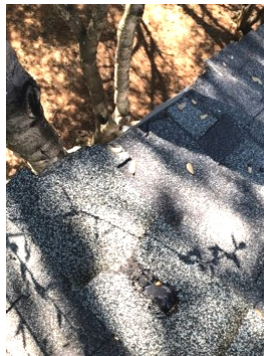
1.2. Damaged shingle(s) noted on roof. Recommend a qualified roofing contractor repair or replace as needed.

Right side tree branch roof damage

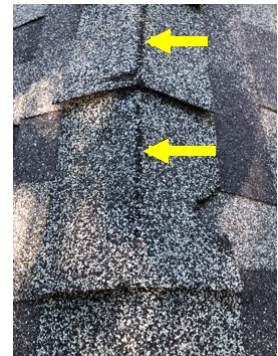
Ridge shingle splitting

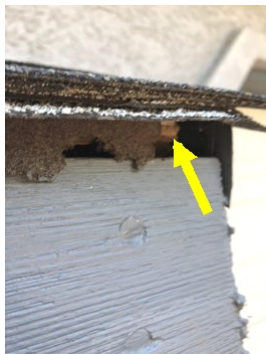
Missing edge flashing

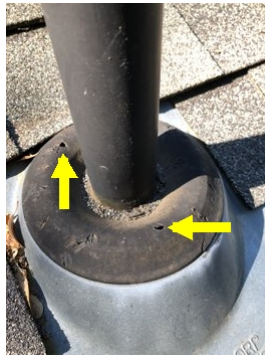
3.1. Vent pipe flashing rubber boot seal(s) noted to be deficient. Recommend replacement as needed.

Holes in vent pipe rubber boot

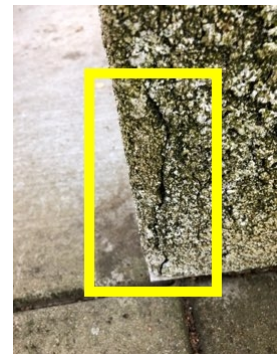
Rear stucco corner crack

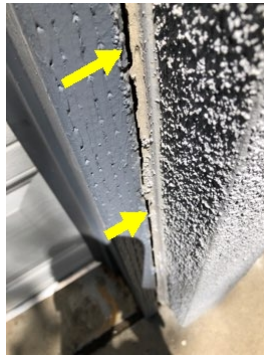
10.1. Poorly sealed **exterior cladding** junctions noted in places. Recommend caulking as needed to avoid moisture intrusion and its related negative effects.

Deficient left vehicle door seal

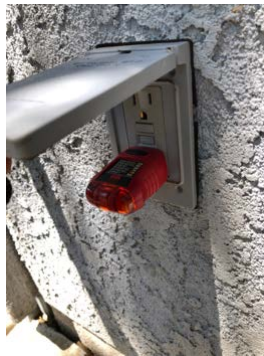
11.1. GFCI without power or would not reset once tripped and is therefore not reliable as a ground fault circuit interrupter. Recommend replacing for safety.

Deficient front right GFCI outlet

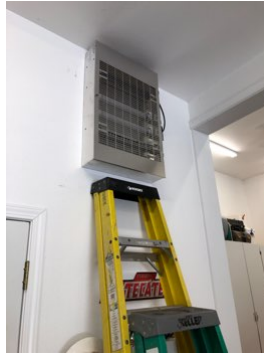
23.1. NOTE: Electric wall heater noted but not inspected. Recommend checking with seller on serviceability.

Wall heater not tested

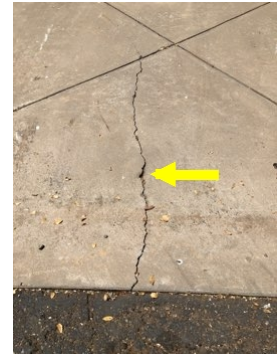
Detached garage driveway cracking
