Signet Inspection Group, Inc.

Comprehensive Property Inspection Report

1001 Scenic Lane, Small Town, CA 12123
Inspection prepared for: Jack & Diane Buyer
Real Estate Agent: Great Agent - All American Real Estate Company

Date of Inspection: 8/1/2019 Time: 9:00 AM
Age of Home: 10 Yrs Size: 4000 sq. ft.
Weather: Clear & Hot
Inspector: Kevin Minto

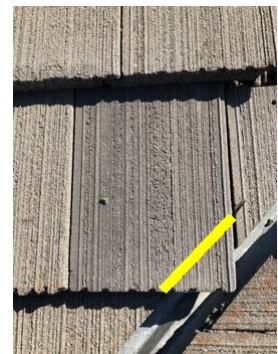
New tile not cut for **valley flashing**

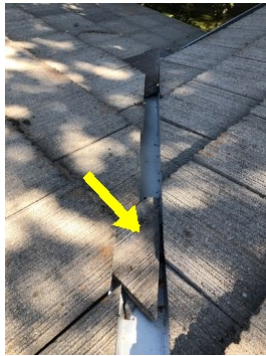
1.4. One or more roof tiles were found to be out of place. Recommend a qualified roofing contractor check for others and reposition/secure as needed.

Loose tile on front center

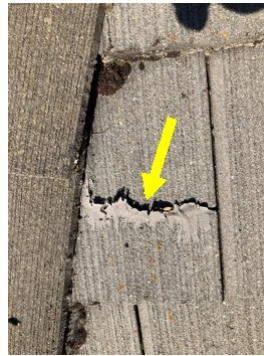
Patched right side tile

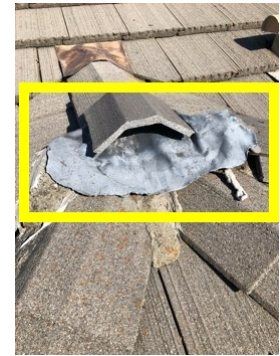
1.1. **NOTE:** Roof hump and/or dip noted which can be caused from a rafter board that has warped over time, has been pushed up by additional bracing or is the result of newer construction. Inspector did note **questionable construction** in attic (see: "Attic > Structure") and therefore could not determine structural significance of hump and/or dip. Since this is only a visual inspection and DOES NOT constitute a certification of structural integrity or lack thereof, if in doubt consider having a qualified professional evaluate the integrity of the structure.

Questionable right ridge junction repair

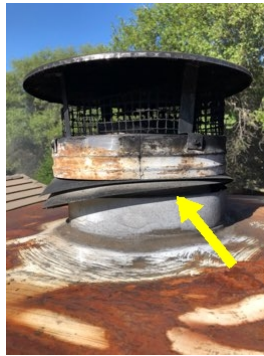
4.2. Chimney flue collar noted as loose. Recommend fastening as needed.

Loose chimney flue collar

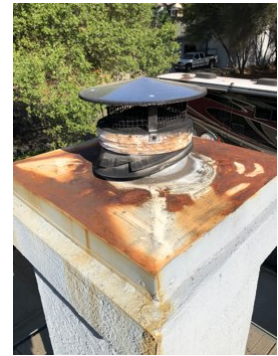
4.1. Metal chimney crown rust noted. Recommend prepping and sealing with a rust-inhibiting paint as needed.

Rusted metal chimney crown

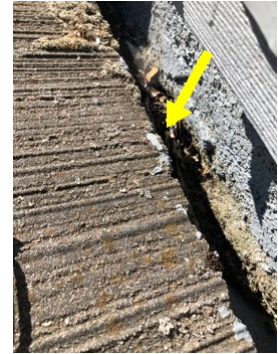
4.5. Clogged flashing noted. Recommend clearing debris, checking for integrity and if necessary, either prepping and painting with a rust-resistant paint or replacing as needed.

Clogged chimney 2 upper flashing

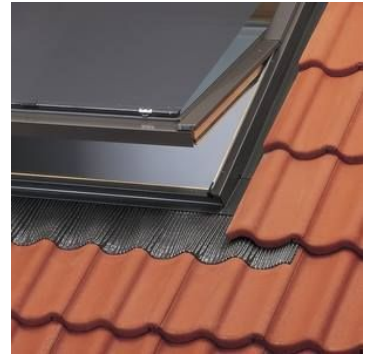
Proper skylight bottom flashing

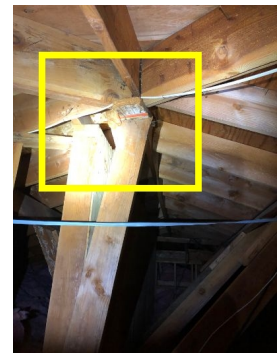
2.3. Questionable construction noted in the form of additional bracing and because of its structural significance considering the weight of a tile roof, this type of work would require a knowledge of load capacities, approved plans and final inspection sign-offs. Recommend checking with seller for such and if necessary, consulting a qualified contractor or structural engineer for further review.

Questionable rafter support

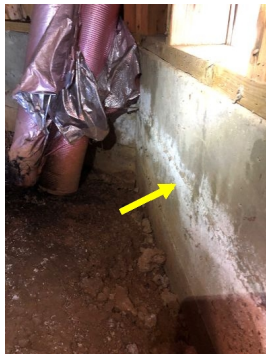
3.1. **Efflorescence** was noted on foundation walls which would indicate water intrusion to some degree. Recommend all Home Inspection Report measures to channel water away from foundation (see notations under: "Grounds > Grading").

Efflorescence on foundation wall

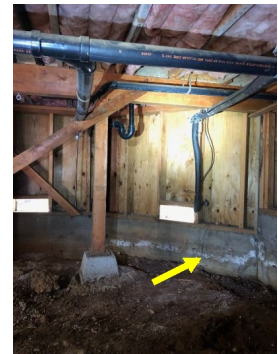
Efflorescence on foundation wall

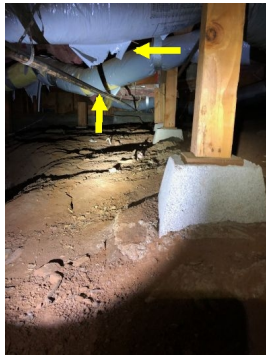
12.2. The vapor barrier on some ducting was noted as torn or missing. Recommend repair as needed.

Torn duct pipe vapor barrier

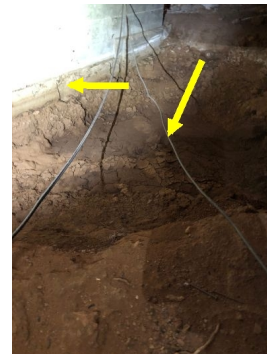
Large pit/exposed footing crack rear right

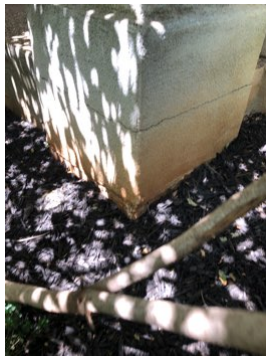
Left column bottom cracking

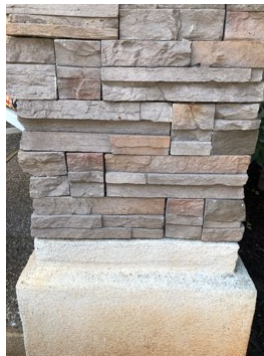
2.2. Masonry veneer noted attached to exterior wood framed columns without any visible weep holes for drainage as recommended by the **IRC** which would prevent moisture the ability to exit should a leak occur. Since adding this feature is not a cost-effective option after the fact, at minimum we recommend an annual check-up to ensure no moisture intrusion is possible.

Drain plane not evident on columns

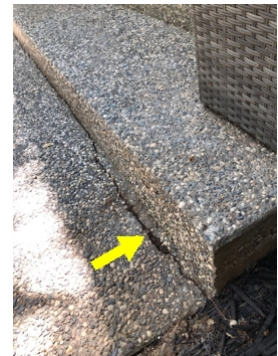
2.3. Moderate cracking was observed in concrete. Further deterioration will occur as water expands and contracts from freeze and thaw cycles and some may become trip hazards as well. Recommend sealing the cracks, continued monitoring and consulting a qualified contractor for remediation options should condition worsen.

Concrete entry stair base cracking

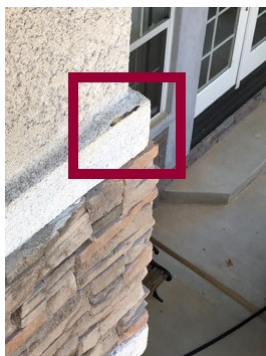
4.1. **Exposed EPS** (encapsulated polystyrene) foam was noted on rear trim. Although durable and resistant to decay, EPS foam is a soft material susceptible to insect intrusion and should not be left exposed. Recommend sealing as needed.

Exposed foam above rear right column

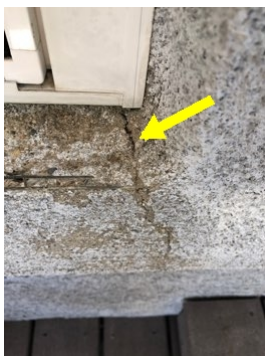
4.2. EPS (encapsulated polystyrene) foam junction cracks were noted. Although EPS is durable and resistant to decay, these cracks can allow moisture to reach the wood wall sheathing which is not resistant to decay. Recommend sealing as needed.

Rear right window trim cracking

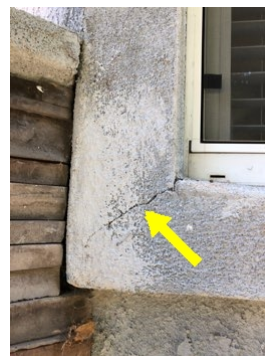
Window trim cracking

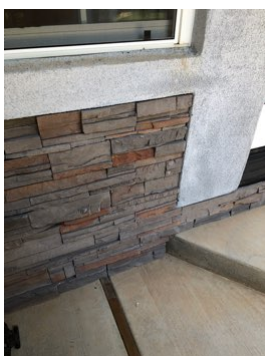
5.2. Masonry veneer noted attached to exterior wood framed wall without any visible weep holes for drainage as recommended by the IRC which would prevent moisture the ability to exit should a leak occur. Since adding this feature is not a cost-effective option after the fact, at minimum we recommend an annual check-up to ensure no moisture intrusion is possible.

No visible drain plane

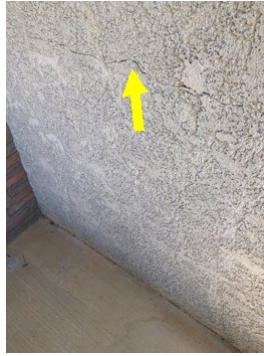
Rear stucco cracking

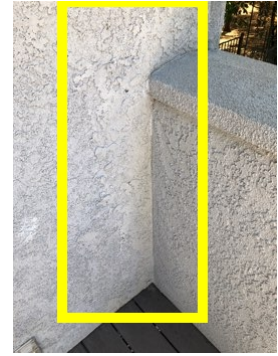
Stucco patch on master deck area

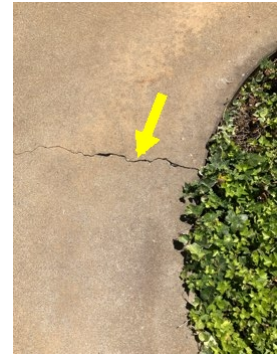
Rear patio cracking

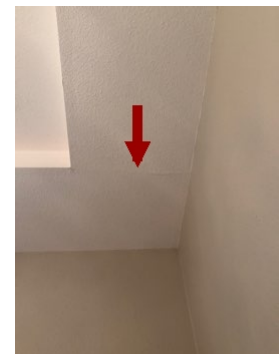
Dining room ceiling seam

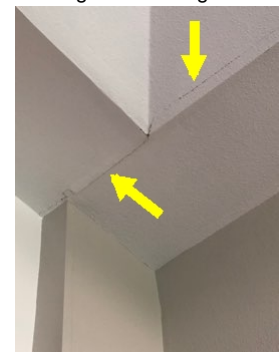
Living room ceiling crack

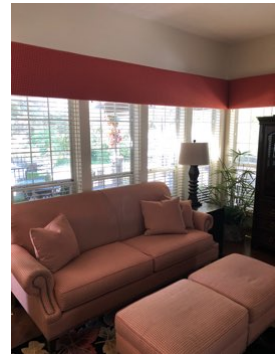
Blocked great room windows

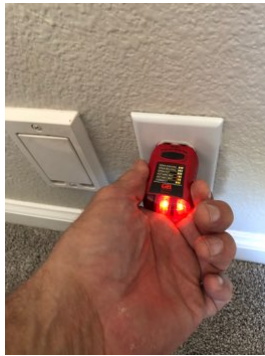
13.1. One or more wall outlet(s) noted to be loose inside box which could loosen wires and cause arcing. Recommend a qualified electrician check for loose wires and tighten as needed.

Loose living room outlet

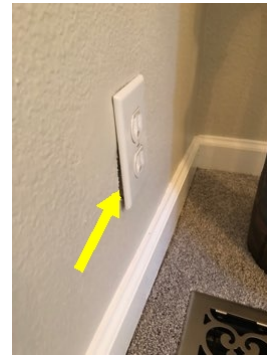
13.2. Outlet cover(s) not flush against wall. Recommend a qualified contractor repair as is needed.

Dining room outlet not flush to wall

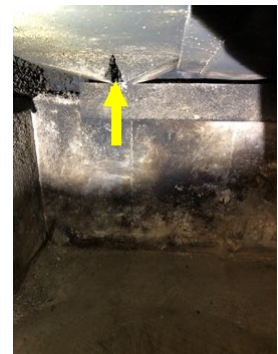
14.3. Damage noted to firebox brick liner. Recommend brick replacement as needed.

Broken firebox brick

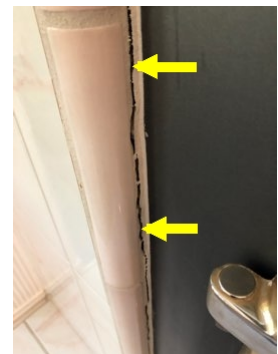
Deficient back wall seal

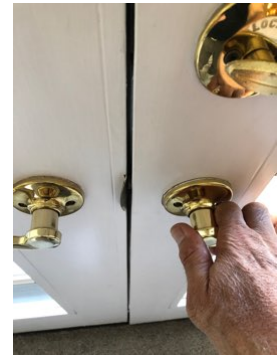
Deficient door latch

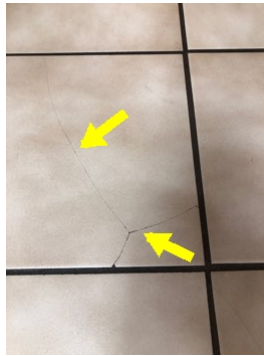
16.2. Cracked or broken tile observed. Recommend sealing or replacing as needed.

Cracked floor tile

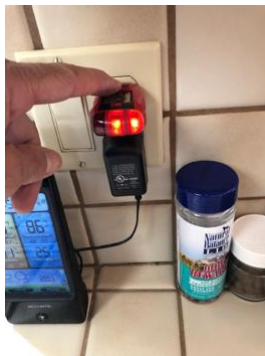
18.1. GFCI did not respond to test with power remaining "on" and is therefore not reliable as a ground fault circuit interrupter. Recommend replacing for safety.

Deficient counter GFCI outlet

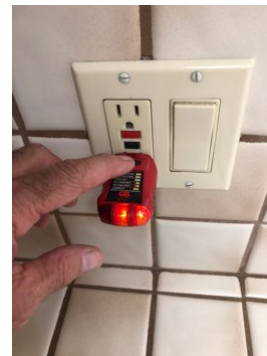
Deficient counter GFCI outlet

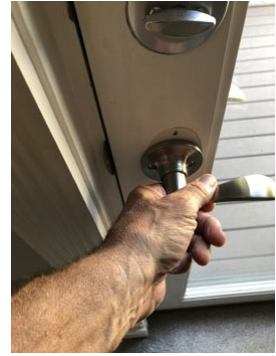
Deficient door latch

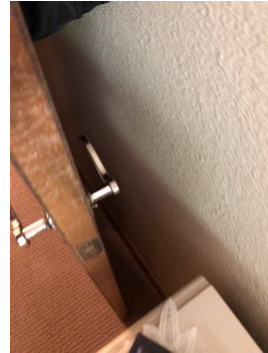
Missing bedroom 4 door stop

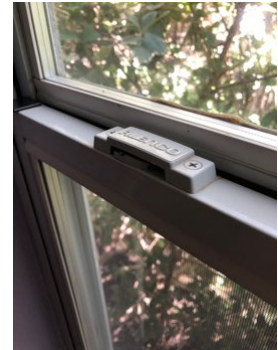
Broken bedroom 3 window latch

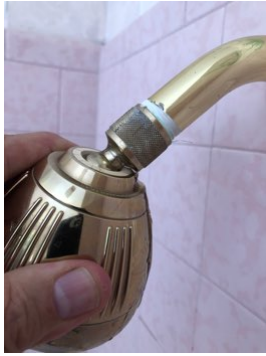
10.1. Shower head and/or hose noted to be leaking. Recommend repair as needed.

Leaking bath 2 shower head

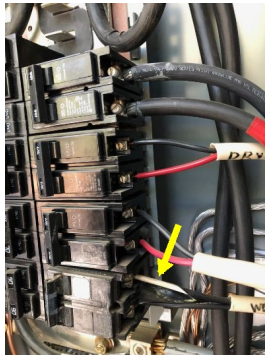
7.1. Unmarked **white wire** used as hot conductor which is not an appropriate and would be considered unsafe to someone working on the electrical system of this house. Recommend re-identification to black or red as needed for safety.

Unmarked white wire in main breaker box

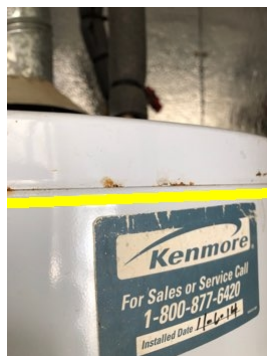
3.1. **Water heater rust and/or corrosion** was noted on outer skin. Recommend monitoring for further leaks and consider replacing sooner rather than later to avoid hot water interruption.

Outer shell rust

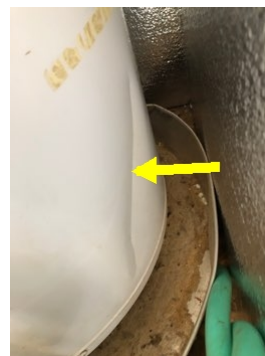
3.2. Water heater outer skin damage noted but did not appear to affect serviceability.

Outer shell damage

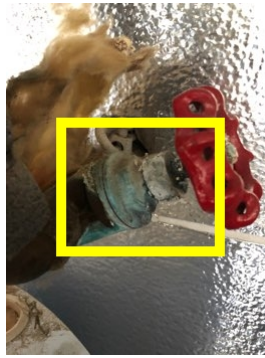
10.1. Water shut-off valve noted as corroded and at risk of, or leaking. Recommend repairs by a qualified plumber as needed.

Corroded water shut-off valve

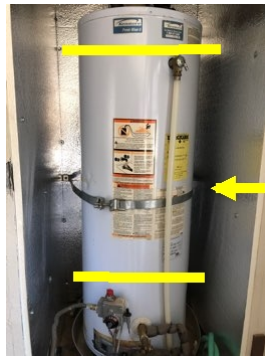
11.1. **Water heater strapping** is not to code which requires two straps 1/3 from both top and bottom. Recommend proper strapping as needed for safety.

Deficient strapping

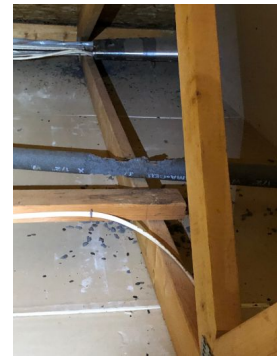
Pipe insulation rodent damage

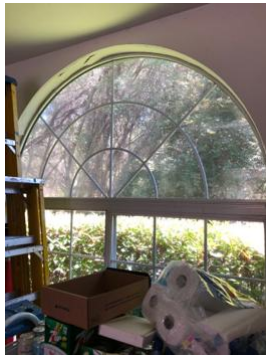
4.1. Fog and/or condensation or the resulting stains were noted in double-pane window(s) which is an indication of a failed seal. Recommend review for repair or replacement as necessary.

Possible failed seal

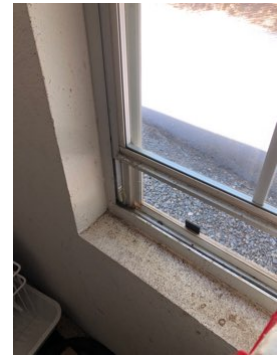
4.2. Broken or weak balance springs noted on window(s). Recommend replacement as needed.

Broken balance spring

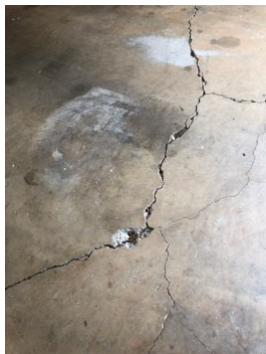
6.1. Large crack(s) noted in concrete garage floor. Recommend sealing, continued monitoring and consulting a qualified contractor for remediation options should conditions dramatically change.

Significant concrete floor cracking

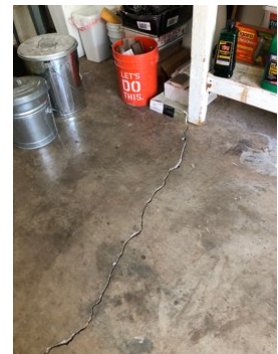
Significant concrete floor cracking

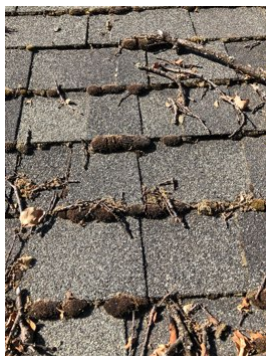
1.1. **Moss on composition** roof noted which can lead to the premature failure of the roof and subsequent leaks. Recommend treating moss during its growing season (wet months) with a moss killer.

Moss on shingle roof

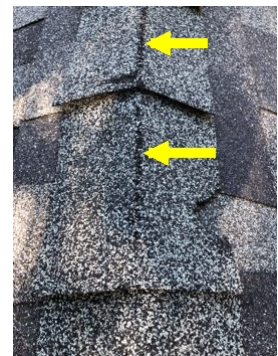
1.2. Damaged shingle(s) noted on roof. Recommend a qualified roofing contractor repair or replace as needed.

Ridge shingle splitting

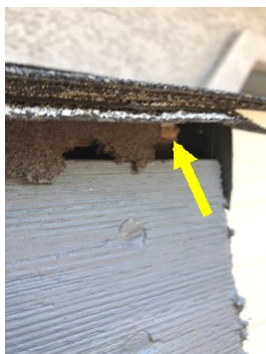
Missing edge flashing

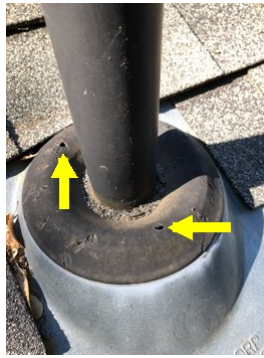
3.1. Vent pipe flashing rubber boot seal(s) noted to be deficient. Recommend replacement as needed.

Holes in vent pipe rubber boot

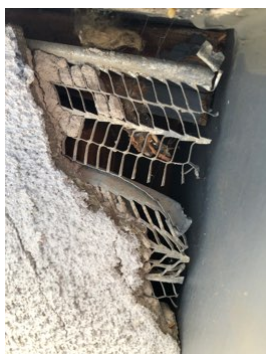
6.1. Eave area soffit board missing with stucco and lath noted to be attached only to rafter blocking and tails which is not best practice. This has already caused stucco breakage, sagging and seam separation from barge rafter. Recommend consulting with a qualified contractor for remediation options.

Exposed eave stucco lath with no backing

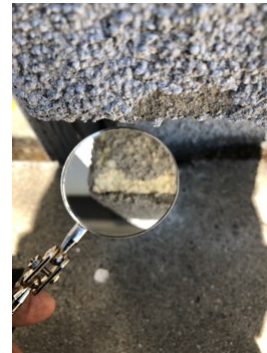
Exposed bottom foam on front trim

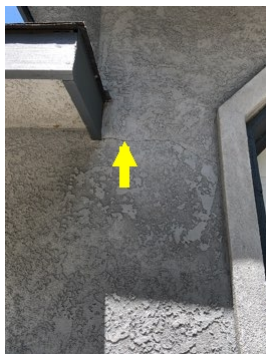
9.1. Stucco crack(s) and/or break(s) exceeding 1/8" noted. Recommend repairing with approved manufacturer's product as needed to avoid moisture intrusion.

Front stucco crack

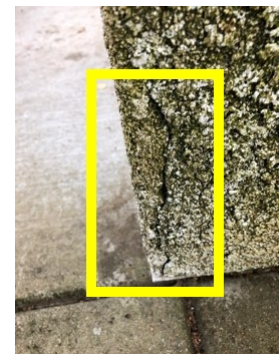
Rear stucco corner crack

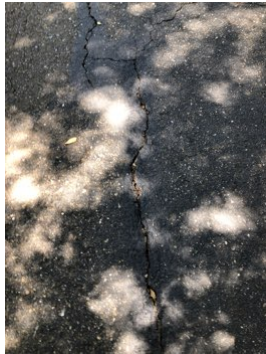
Asphalt driveway cracking
