Signet Home Inspections, LLC

Comprehensive Property Inspection Report

1001 Scenic Lane, Small Town, CA 12123
Inspection prepared for: Jack & Diane Buyer
Real Estate Agent: Great Agent - All American Real Estate Company

Date of Inspection: 8/1/2019 Time: 9:00 AM

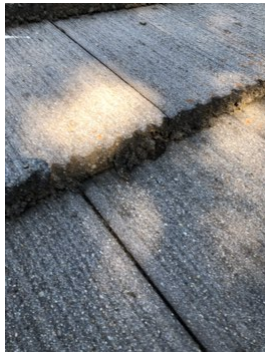
1.3. **Moss on tile** roof noted which can lead to the premature failure of the roof and subsequent leaks. Recommend treating moss during its growing season (wet months) with a moss killer.

Moss on roof tile

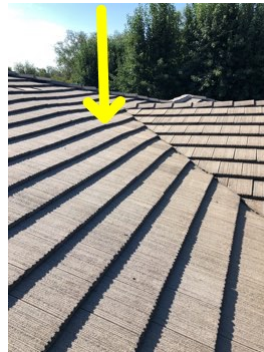
1.1. **NOTE:** Roof hump and/or dip noted which can be caused from a rafter board that has warped over time, has been pushed up by additional bracing or is the result of newer construction. Inspector did note **questionable construction** in attic (see: "Attic > Structure") and therefore could not determine structural significance of hump and/or dip. Since this is only a visual inspection and DOES NOT constitute a certification of structural integrity or lack thereof, if in doubt consider having a qualified professional evaluate the integrity of the structure.

Front right hump

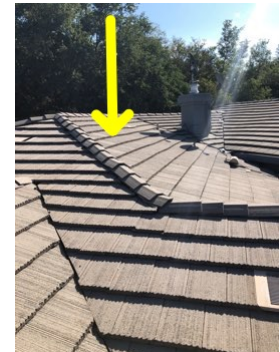
Rear roof waviness

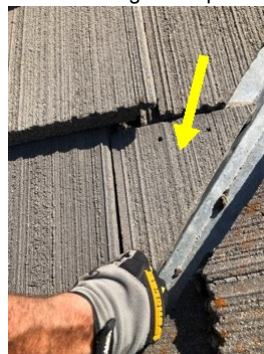
1.4. One or more roof tiles were found to be out of place. Recommend a qualified roofing contractor check for others and reposition/secure as needed.

Loose valley tile

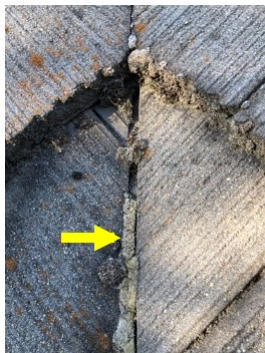
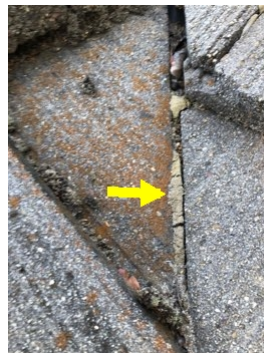
2.1. Clogged **valley flashing** noted which is meant to direct water into a gutter. Recommend unclogging and further investigation for moisture intrusion.

Moss clogging valley flashing

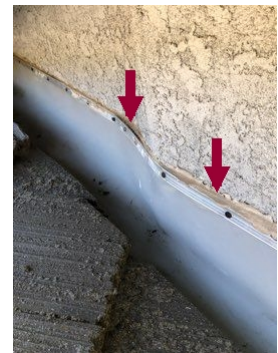
2.2. Questionable sidewall flashing noted with flashing on top of stucco with screws and caulking as opposed to underneath as is preferred. Recommend checking with seller for details and consulting with a qualified contractor for further review and remediation options. Since these types of sealants will normally last 5 years at best, if nothing is done we recommend monitoring for future leaks.

Questionable sidewall flashing

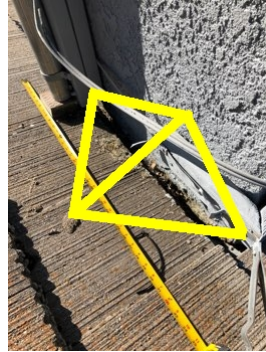
4.4. No "**Crickle**" was installed above chimney to divert rain water which would now be considered mandatory in new construction. Consequently it is advisable to keep area clean of any accumulated debris which will cause rust and eventual leaks.

Missing cricket to divert water

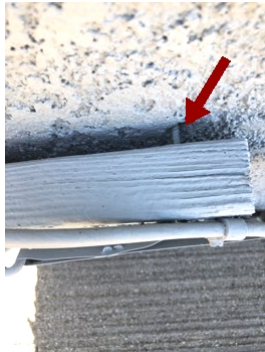
4.6. Satellite dish support frame noted to be separating from stucco chimney enclosure. Recommend consulting with a qualified contractor for remediation options.

Separating satellite wooden support

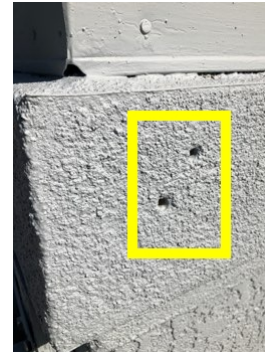
4.7. Open stucco penetration(s) noted. Recommend sealing to avoid moisture intrusion.

Unsealed chimney 2 holes

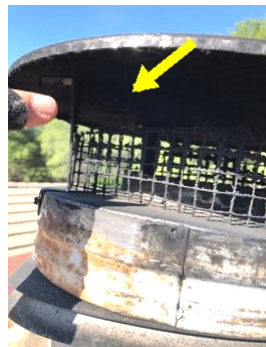
5.1. Spark arrestor screen gap(s) over 1/2" noted which violates California Building Code-Section 3102.3.8 which states; "Openings shall not permit passage of spheres having a diameter larger than 1/2" and shall not block the passage of spheres having a diameter of less than 3/8". Recommend replacing with a proper spark arrestor screen.

Large gap in spark arrestor

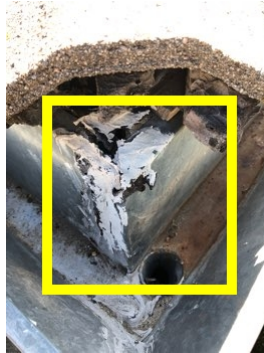
7.2. Newly caulked gutter seam(s) noted. Normally if one seam fails others are close behind so we recommend checking with seller on extent of the repairs and if necessary monitoring for future leaks.

Rear right gutter seam caulk seal

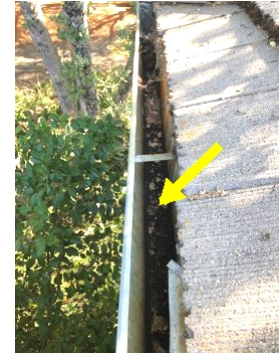
7.1. Gutters with organic materials were noted. Recommend cleaning to avoid downspout clogging and premature gutter deterioration. Consider adding gutter screens to avoid future problems.

Gutter clogged with organic material

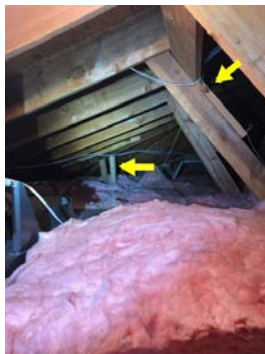
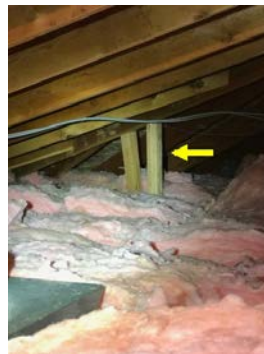
2.3. Questionable construction noted in the form of additional bracing and because of its structural significance considering the weight of a tile roof, this type of work would require a knowledge of load capacities, approved plans and final inspection sign-offs. Recommend checking with seller for such and if necessary, consulting a qualified contractor or structural engineer for further review.

Questionable rafter support

Questionable rafter support close-up

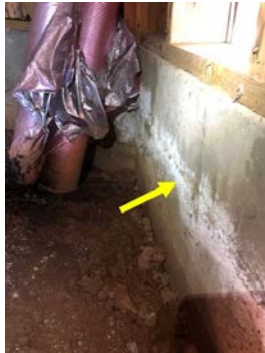
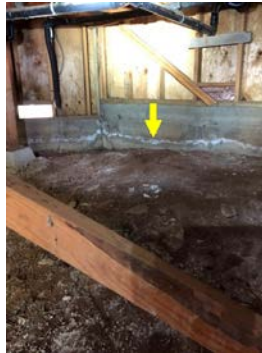
3.1. **Efflorescence** was noted on foundation walls which would indicate water intrusion to some degree. Recommend all Home Inspection Report measures to channel water away from foundation (see notations under: "Grounds > Grading").

Efflorescence on foundation wall

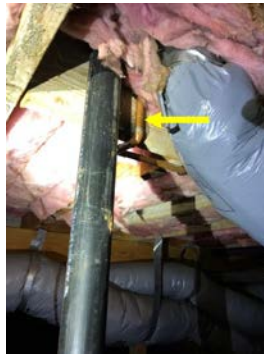
10.3. Missing or deficient unheated area pipe insulation noted. Recommend repair or adding as needed.

Missing copper pipe insulation

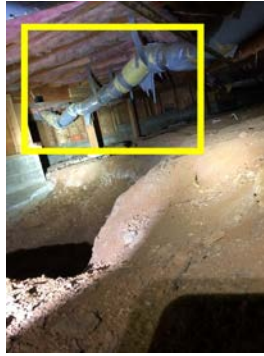
Torn duct pipe vapor barrier

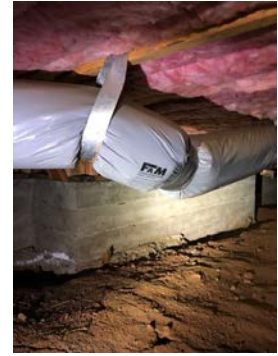
Restrictive duct pipe strapping

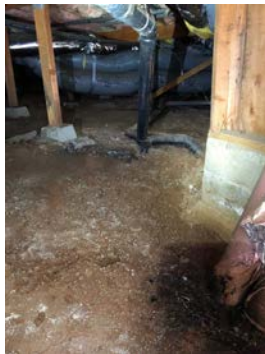
14.1. Areas of crawlspace soil noted as damp at time of inspection. Recommend all actions to minimize foundation area water intrusion (see "Grounds > Grading" and "Roof > Downspouts").

Damp crawlspace soil

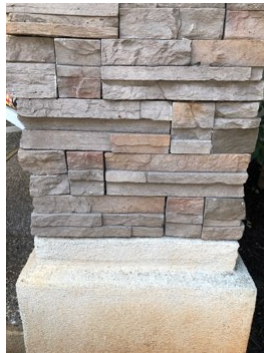
Drain plane not evident on columns

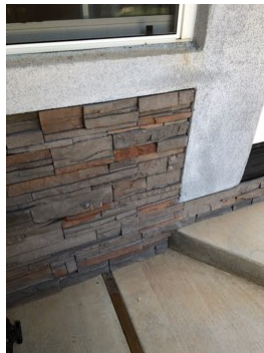
5.2. Masonry veneer noted attached to exterior wood framed wall without any visible weep holes for drainage as recommended by the IRC which would prevent moisture the ability to exit should a leak occur. Since adding this feature is not a cost-effective option after the fact, at minimum we recommend an annual check-up to ensure no moisture intrusion is possible.

No visible drain plane

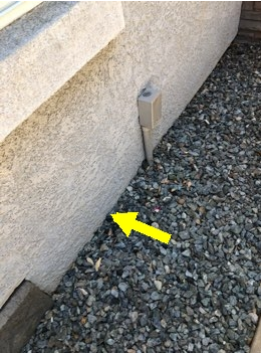
Weep screed covered on right side

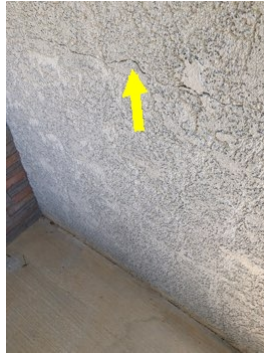
6.3. Stucco crack(s) and/or break(s) exceeding 1/8" noted. Recommend repairing with approved manufacturer's product as needed to avoid moisture intrusion.

Rear stucco cracking

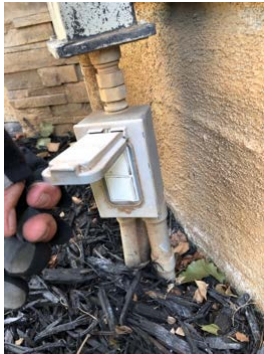
8.1. NOTE: One or more wall switch functionalities were not identified and therefore not inspected. Recommend checking with seller to identify usage and confirm serviceability.

Unknown rear right

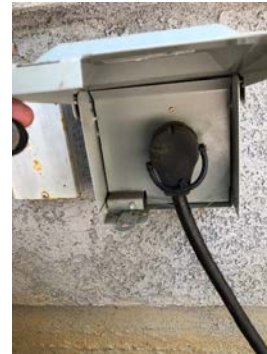
8.2. NOTE: One or more outlets blocked and not accessible. Recommend checking when clear.

Untested outlet near RV parking

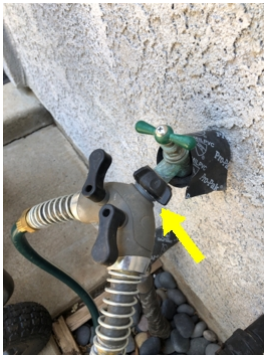
10.1. Anti-siphon hose bibb vacuum breakers not present on outdoor faucets. Most likely not required when home was built, they would now be required for new construction. Although you would be under no obligation to do so, consider adding for safety.

Hose bibb without vacuum breaker

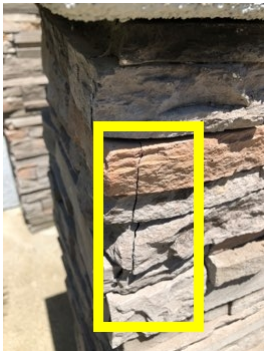
11.3. Masonry column cladding crack(s) noted. Recommend sealing to avoid water intrusion and damage caused by the winter freeze/thaw cycle.

Deck railing stone column cracking

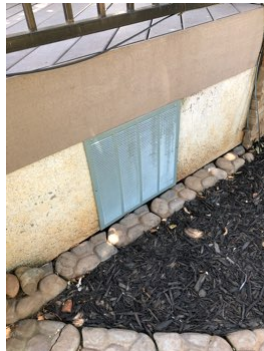
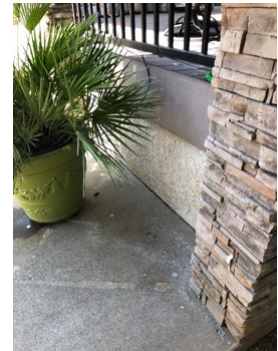
11.2. NOTE: Some deck areas where blocked or out-of-reach and not accessible for a visible inspection including joist, beam and post connections.

No access under deck

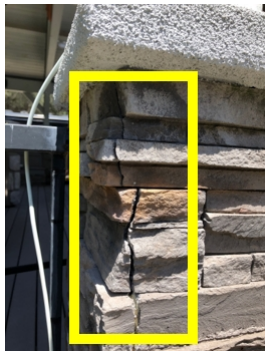
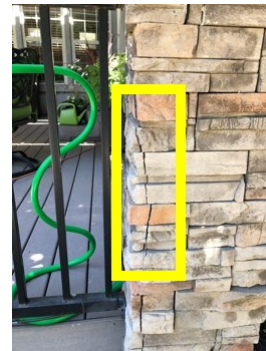
12.1. Masonry column cladding crack(s) noted. Recommend sealing to avoid water intrusion and damage caused by the winter freeze/thaw cycle.

Deck railing stone column cracking

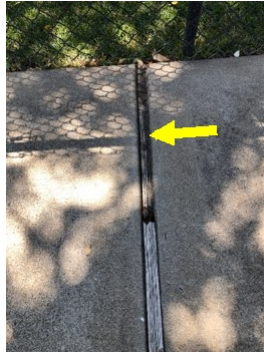
Wood decay on right patio expansion joint

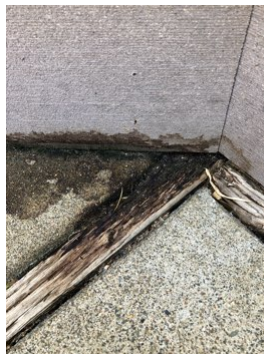
14.1. Moisture staining with early stages of wood decay noted. Recommend eliminating water source.

Right side landing moisture damage

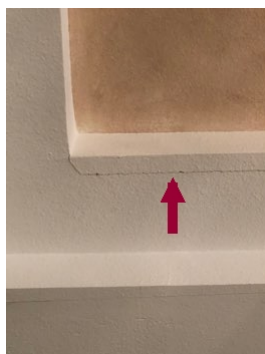
4.1. **Sheetrock crack(s)** noted which normally represents a cosmetic issue as opposed to a structural problem. Consider patching with a flexible caulking to reduce or eliminate eyesore.

Dining room ceiling crack

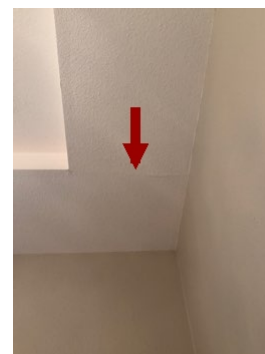
Dining room ceiling seam

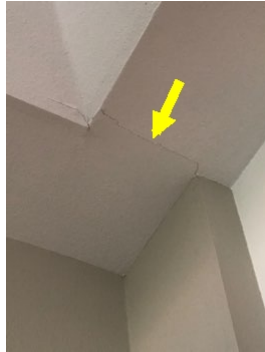
Living room ceiling crack

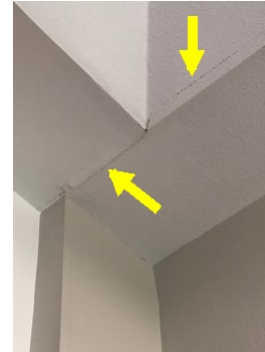
Living room ceiling crack

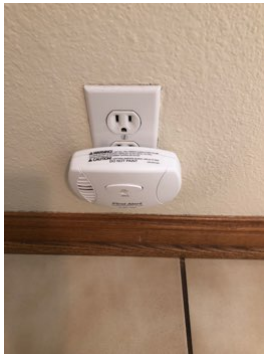
Hallway CO alarm detail

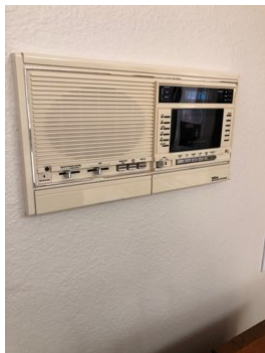
7.1. NOTE: An intercom system was noted with speaker boxes and main control panel. Since testing this system is beyond the scope of this inspection, it is recommended the buyer seek operation guidance from the seller and if necessary, that a qualified professional check the system for serviceability.

Intercom system control panel

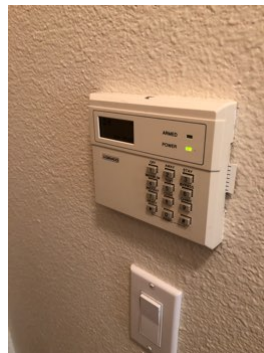
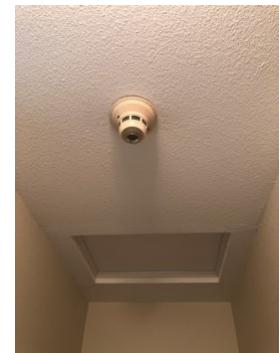
7.2. NOTE: A security system was noted with wall sensors, ceiling alarms and a control panel. Since testing this system is beyond the scope of this inspection, it is recommended the buyer seek operation guidance from the seller and if necessary, that a qualified professional check the system for serviceability.

Security system control pad detail

Security system smoke/CO alarm sensor

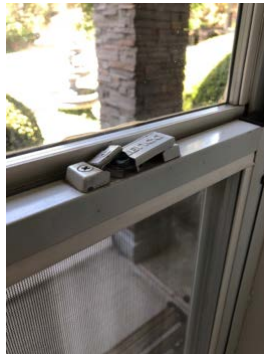
9.4. Broken latch on window(s) noted. Recommend repairs or replacement as needed.

Living room window broken latch

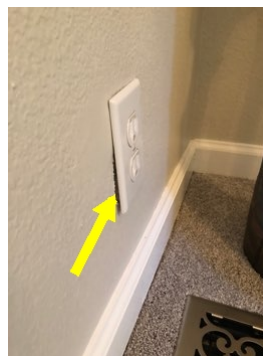
13.2. Outlet cover(s) not flush against wall. Recommend a qualified contractor repair as is needed.

Dining room outlet not flush to wall

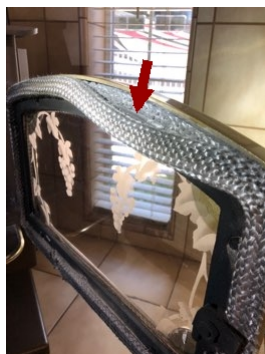
14.2. Wood stove door gasket was noted as deficient or missing which can allow CO gases into the living space. Recommend replacement as needed.

Deficient wood stove door gasket

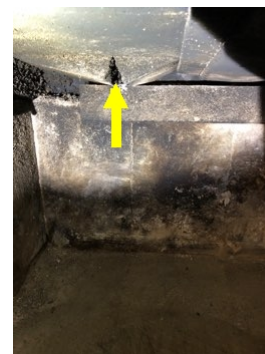
14.3. Damage noted to firebox brick liner. Recommend brick replacement as needed.

Broken firebox brick

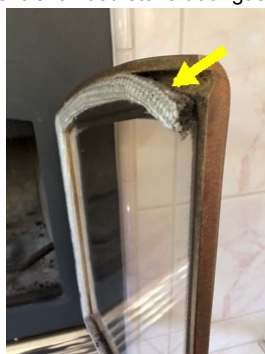
14.4. Fireplace hearth, wall or mantel deficiency noted. Recommend repairs as needed.

Deficient door gasket

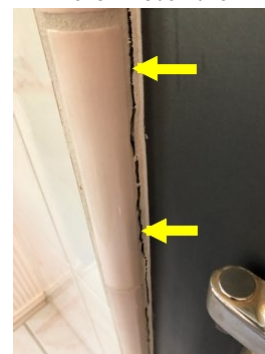
Deficient back wall seal

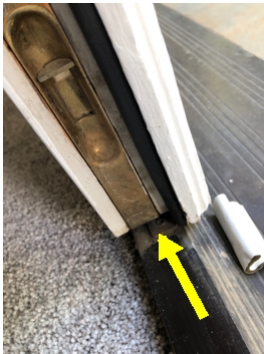
18.2. Inactive part of double door could not be fully latched and/or opened for reasons unknown. Recommend consulting with a qualified contractor for remediation options.

Living room inactive door would not open

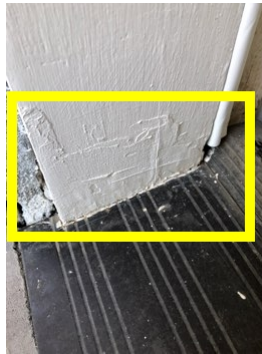
18.3. Damage to door jamb and/or threshold noted. Recommend repairs as needed.

Patched door jamb bottom

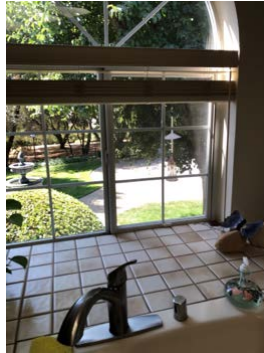
3.1. Window(s) noted to be difficult to open for reasons unknown. Recommend cleaning and lubricating friction points or consulting a qualified window repair contractor for remediation options.

Difficult to open window

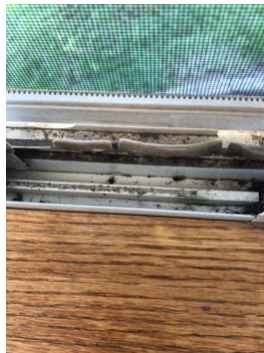
4.1. Screen noted to be damaged on window(s). Recommend repairing or replacing as needed.

Cracked window screen seal

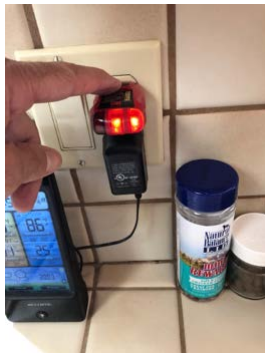
18.1. GFCI did not respond to test with power remaining "on" and is therefore not reliable as a ground fault circuit interrupter. Recommend replacing for safety.

Deficient counter GFCI outlet

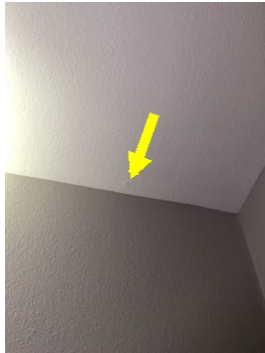
3.1. Popping sheetrock nail heads noted. Recommend repairs as needed.

Ceiling nail pop

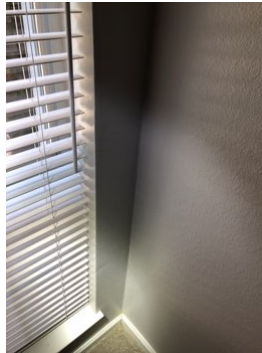
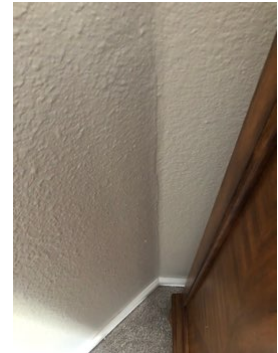
3.2. Patched area(s) of sheetrock noted with reason undetermined. Recommend checking with seller for further details.

Wall corner patch

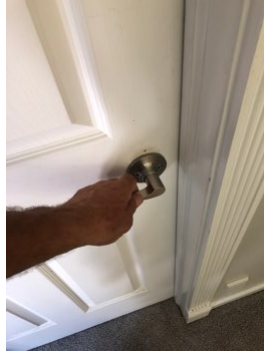
8.2. Door would not latch closed. Recommend repair as needed.

Deficient door latch

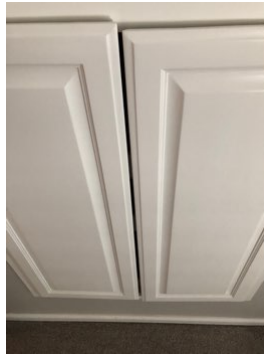
9.1. Misaligned cabinet door(s) noted being prevented from closing properly. Recommend adjustments as needed to close without sticking.

Misaligned doors under TV

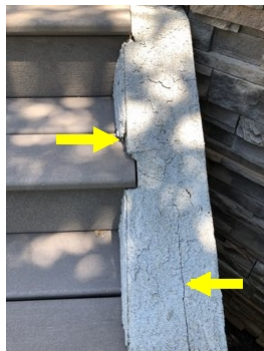
17.2. Cracking stucco stair stringer stucco cap noted. Recommend repairs as needed.

Stair stringer cap stucco cracking

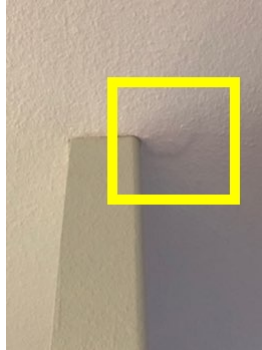
1.1. Unknown sheetrock bulge noted. Recommend checking with seller for further details.

Unknown ceiling bulge above shower

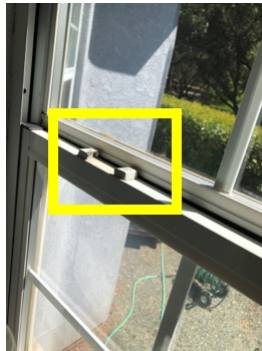
2.2. Broken latch on window(s) noted. Recommend repairs or replacement as needed.

Broken latch in toilet room

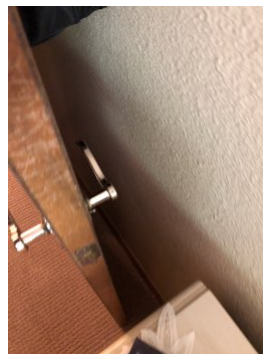
Missing bedroom 4 door stop

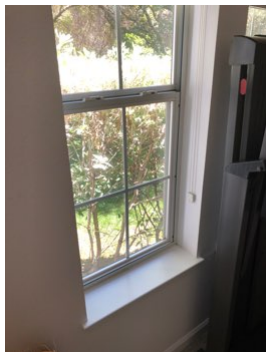
6.2. Broken or weak balance springs noted on window(s). Recommend replacement as needed.

Bedroom 2 broken balance spring

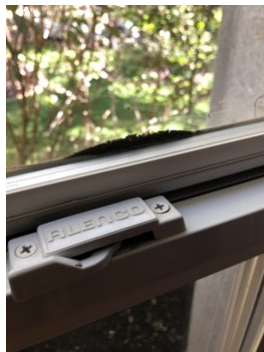
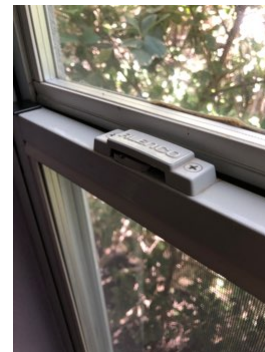
Broken bedroom 3 window latch

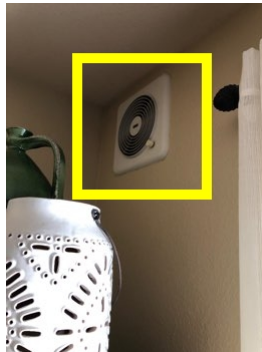
11.2. NOTE: Unknown wall fan was noted but not inspected. Recommend checking with seller for further details.

Unknown bedroom 4 fan

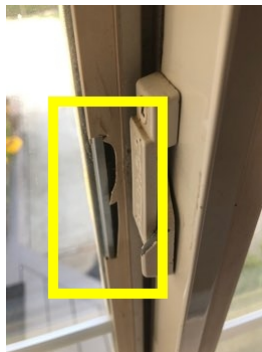
12.1. Damage to door skin or surface noted. Recommend repairs as needed.

Damaged bedroom 4 exterior door

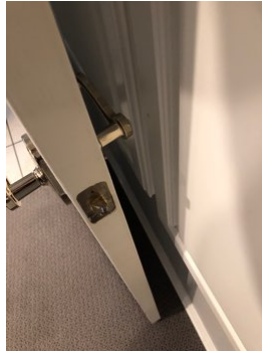
2.1. Missing, poorly adjusted or damaged door stop noted which serves to protect wall or other surfaces from damage. Recommend adding, adjusting or replacing as needed.

Missing half bath door stop

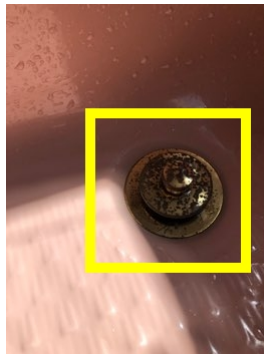
8.1. Worn tub stopper finish noted and it is not known if it can be restored to its original condition.

Worn bath 2 tub stopper

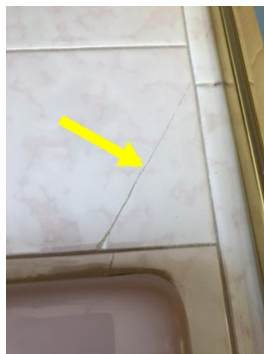
9.1. Cracked or broken tile(s) noted. Recommend sealing or replacing as needed.

Cracked tub deck tile

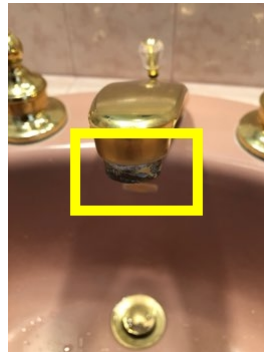
13.2. Sink faucet noted to be corroded at spout. Recommend repair or replacement as needed.

Worn bath 2 faucet finish

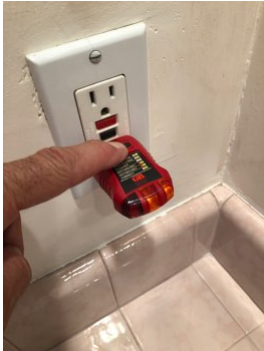
19.1. GFCI did not respond to test with power remaining "on" and is therefore not reliable as a ground fault circuit interrupter. Recommend replacing for safety.

Deficient bath 2 GFCI with power on

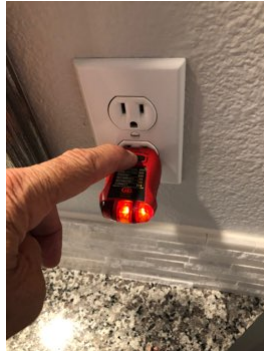
No half bath outlet GFCI protection

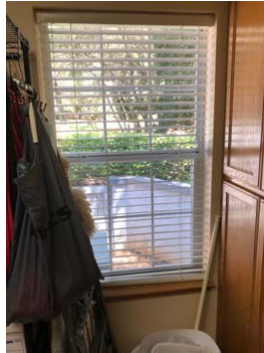
3.1. NOTE: Window(s) noted to be inaccessible and therefore not inspected. Recommend removing obstacle(s) and inspecting as needed.

Blocked by faulty blinds

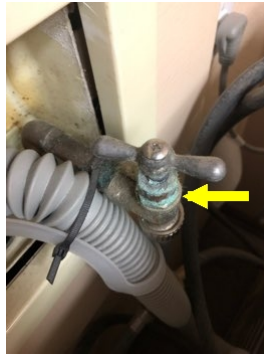
10.1. Water angle stop noted as worn or leaking. Recommend a qualified plumber replace with a quarter-turn angle stop.

Corrosion on washer water valve

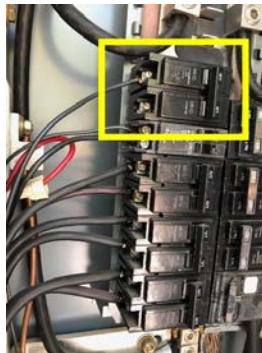
6.1. 2-pole breaker on main breaker box noted to be half loaded (one wire instead of two as intended). The breaker must be able to trip before the wires connected to it can become damaged and a 2-pole breaker only loaded on one half is likely to have too much mechanical resistance to do that which can lead to wire overheating and possible fire danger. Recommend a qualified contractor repair as needed for safety.

Half loaded 2-pole breaker in main breaker box

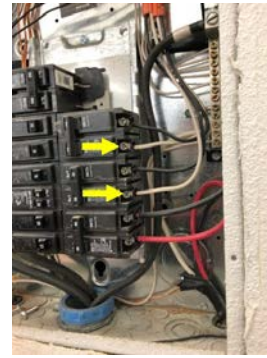
7.1. Unmarked **white wire** used as hot conductor which is not an appropriate and would be considered unsafe to someone working on the electrical system of this house. Recommend re-identification to black or red as needed for safety.

Unmarked white wire on sub panel

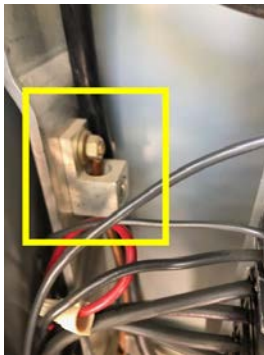
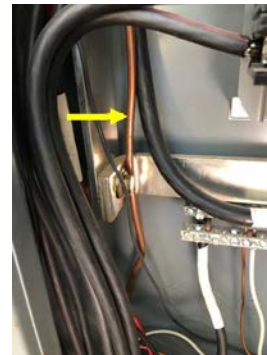
Location: NOTE: Grounding wire noted in panel box but electrode not located.

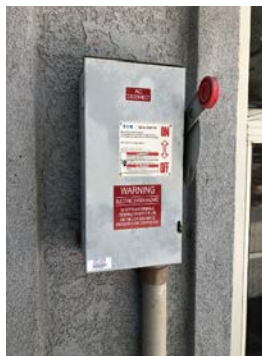
9.1. NOTE: Auxiliary generator and/or switch box noted but not inspected. Recommend confirming serviceability and if necessary a full evaluation by a qualified electrician.

Main disconnect possibly for generator use

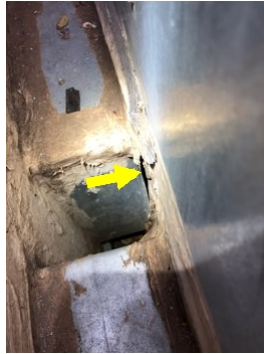
6.1. Deficient plenum seal noted which will allow rain penetration and vermin intrusion. Recommend sealing as needed.

Deficient plenum seal

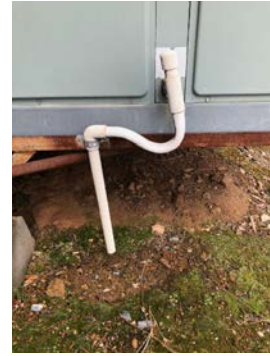
10.1. Condensate drain line water trap noted to be broken, deficient or missing. Recommend repairs or replacement as needed by a qualified HVAC contractor.

Example of proper condensate trap

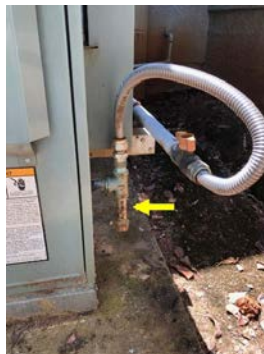
9.1. Sediment trap was in place and appeared serviceable at time of inspection.

Gas line with sediment trap

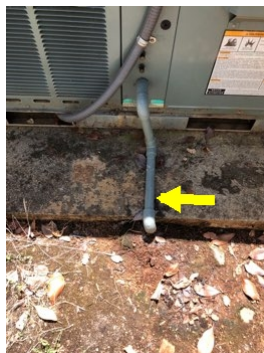
10.1. Condensate drain line water trap noted to be broken, deficient or missing. Recommend repairs or replacement as needed by a qualified HVAC contractor.

Missing trap on condensate drain line

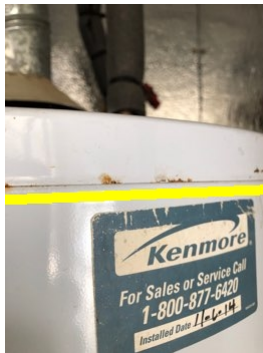
3.1. **Water heater rust and/or corrosion** was noted on outer skin. Recommend monitoring for further leaks and consider replacing sooner rather than later to avoid hot water interruption.

Outer shell rust

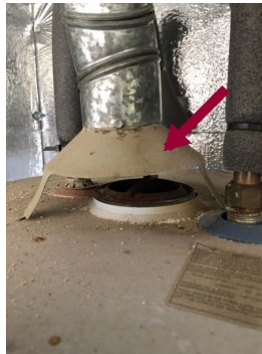
6.1. Flue pipe and gas appliance noted as slightly misaligned and potentially not properly carrying exhaust gases to the exterior. Recommend aligning as needed for safety.

Misaligned vent pipe

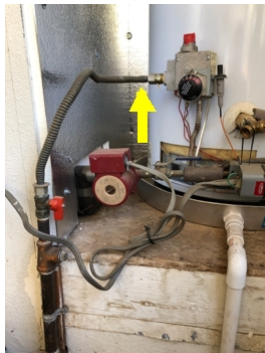
9.1. Sediment trap is missing and most likely not required when this house was built, sediment traps are now required by the Uniform Plumbing Code and are therefore incorporated into most, if not all, city building and safety codes. Although you would be under no obligation to do so, consider adding to increase appliance longevity.

Gas line without sediment trap

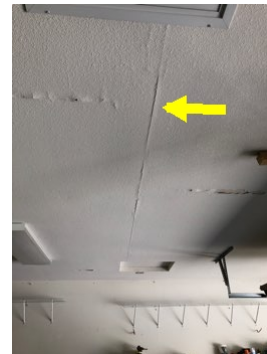
2.1. Area of sheetrock joint tape noted as lifting and cracking and some sheetrock surface damage noted. Recommend repairs as needed.

Lifting seam tape

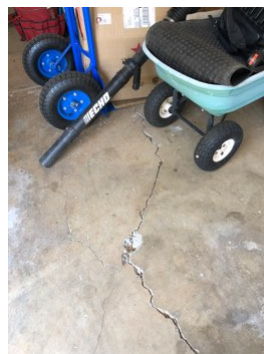
6.1. Large crack(s) noted in concrete garage floor. Recommend sealing, continued monitoring and consulting a qualified contractor for remediation options should conditions dramatically change.

Significant concrete floor cracking

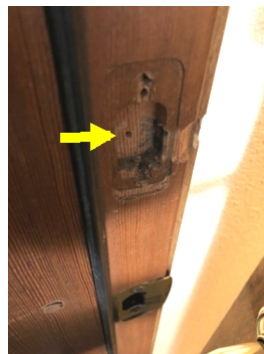
7.2. Missing strike plate noted allowing closed door to move in and out. Recommend adding as needed.

Missing strike plate

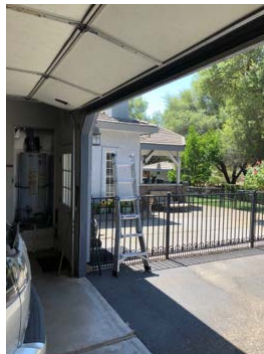
10.2. Auto-reverse feature on double-car vehicle door noted as not present or not adjusted properly and either not reversing at all or requiring too much resistance to reverse. This is a serious safety concern for small children and animals and we recommend immediate remediation as necessary for safety

Deficient large door auto-reverse

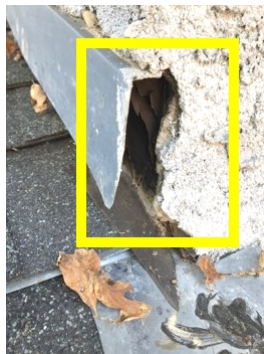
2.2. Deficient front sidewall base flashing termination with large unsealed gap noted. Recommend sealing as needed to avoid moisture intrusion.

Front gap in flashing

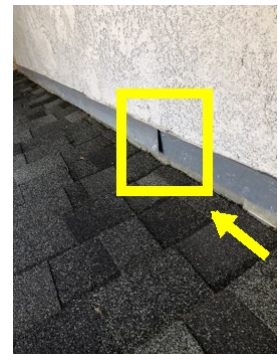
2.3. Sidewall base flashing noted to be stepped in wrong direction with downhill section overlapping uphill section. Recommend consulting with a qualified roofing contractor for remediation options.

Wrong overlap on stucco sidewall flashing

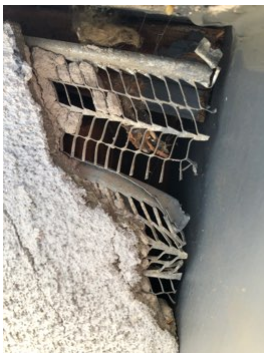
6.1. Eave area soffit board missing with stucco and lath noted to be attached only to rafter blocking and tails which is not best practice. This has already caused stucco breakage, sagging and seam separation from barge rafter. Recommend consulting with a qualified contractor for remediation options.

Exposed eave stucco lath with no backing

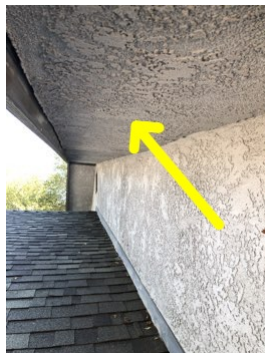
Sag in eave stucco

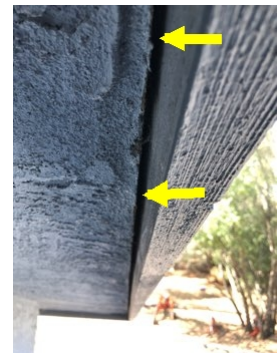
Stucco separation from barge rafter

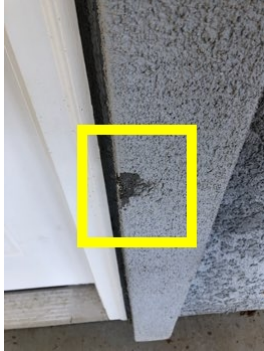
8.1. Damaged trim noted from unknown cause. Recommend repairs as needed.

Left stucco trim damage

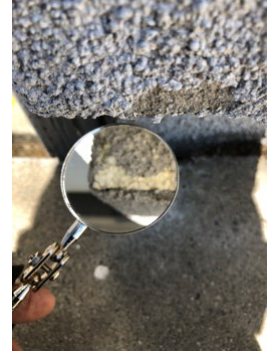
8.2. Exposed EPS (encapsulated polystyrene) foam was noted at trim base. Although durable and resistant to decay, EPS foam is a soft material susceptible to insect intrusion and should not be left exposed. Recommend sealing as needed.

Exposed bottom foam on front trim

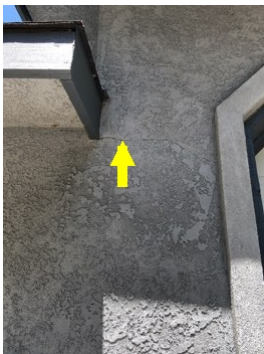
9.1. Stucco crack(s) and/or break(s) exceeding 1/8" noted. Recommend repairing with approved manufacturer's product as needed to avoid moisture intrusion.

Front stucco crack

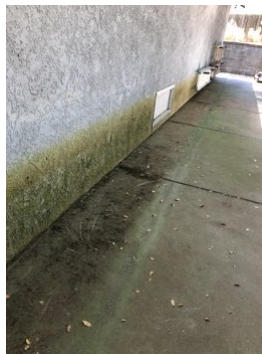
9.2. Water stains noted on rear wall cladding from rain water spaying off rear walkway due to lack of gutter to divert water into drain line. Recommend further review by a qualified contractor to determine if any wall cladding moisture intrusion has occurred as a result.

Rear stucco staining

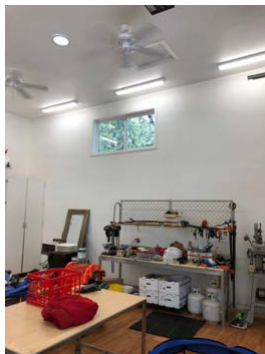
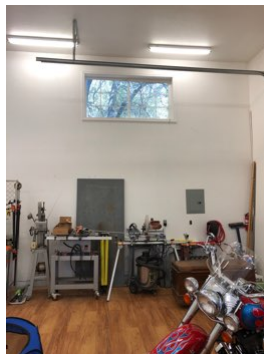
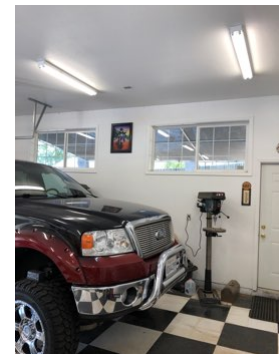
13.1. NOTE: Window(s) noted to be inaccessible and therefore not inspected. Recommend removing obstacle(s) and inspecting as needed.

Unreachable window

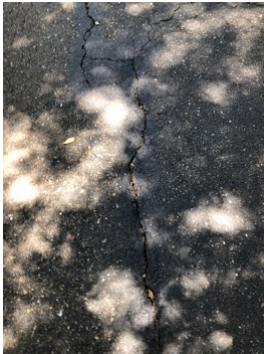
1.1. Moderate cracking was observed in driveway and/or walkway(s). Further deterioration will occur as water expands and contracts from freeze and thaw cycles and some may become trip hazards as well. Recommend sealing the cracks, continued monitoring and consulting a qualified contractor for remediation options should condition worsen.

Asphalt driveway cracking

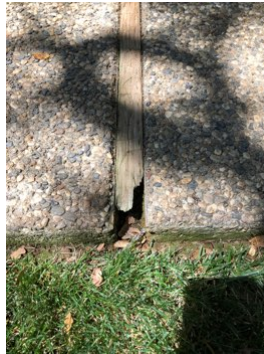
1.2. Decayed concrete wood expansion joint(s) noted. Recommend replacing or filling void as needed to avoid gap.

Front walkway expansion joint wood decay

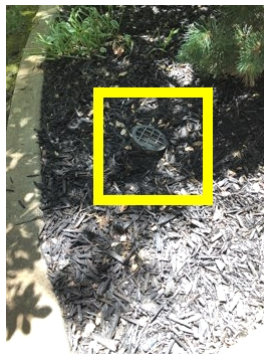
Front drain grate detail

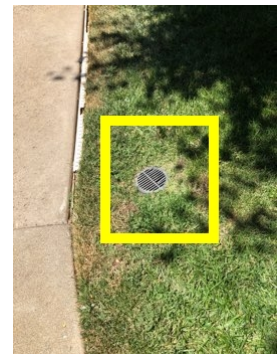
3.2. NOTE: A **lot drainage** system was noted but not inspected. Recommend checking with seller on serviceability.

Rear drainage grate detail

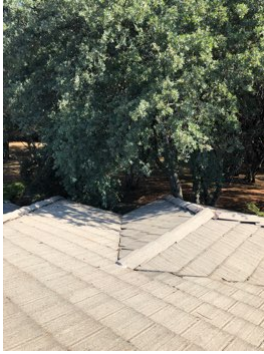
4.1. **Overhanging tree limbs** noted on portions of the roof which can result in roof damage. Recommend a professional

Tree branches overhanging roof deck

tree service trim as needed.

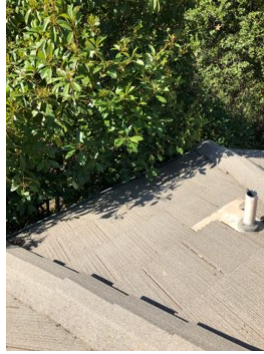
Tree branches overhanging roof deck

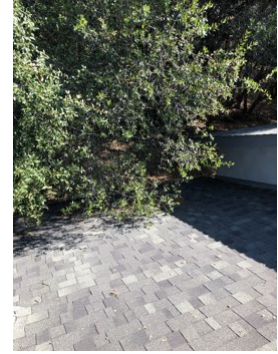
Tree branches overhanging detached garage

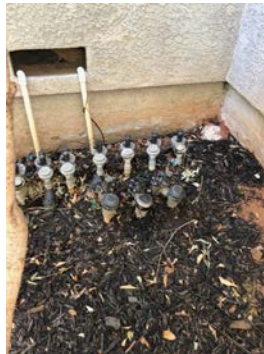
6.1. NOTE: An outdoor irrigation system was noted with sprinkler valves and a control panel. Since testing this system is beyond the scope of this inspection, it is recommended the buyer seek operation guidance from the seller and that a qualified landscaping professional check the system for serviceability.

Irrigation system sprinkler valves
