Signet Inspection Group, Inc.

Comprehensive Property Inspection Report

1001 Scenic Lane, Small Town, CA 12123
Inspection prepared for: Jack & Diane Buyer
Real Estate Agent: Great Agent - All American Real Estate Company

Date of Inspection: 8/1/2019 Time: 9:00 AM
Age of Home: 10 Yrs Size: 4000 sq. ft.
Weather: Clear & Hot
Inspector: Kevin Minto

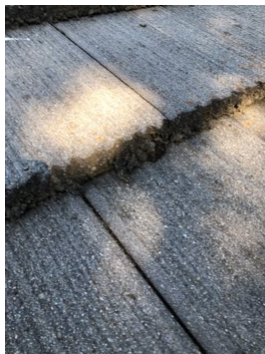
1.3. **Moss on tile** roof noted which can lead to the premature failure of the roof and subsequent leaks. Recommend treating moss during its growing season (wet months) with a moss killer.

Moss on roof tile

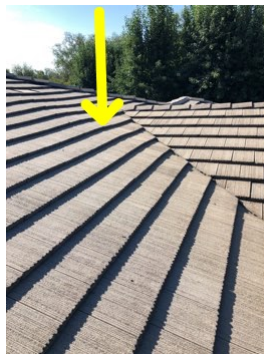
1.1. **NOTE:** Roof hump and/or dip noted which can be caused from a rafter board that has warped over time, has been pushed up by additional bracing or is the result of newer construction. Inspector did note **questionable construction** in attic (see: "Attic > Structure") and therefore could not determine structural significance of hump and/or dip. Since this is only a visual inspection and DOES NOT constitute a certification of structural integrity or lack thereof, if in doubt consider having a qualified professional evaluate the integrity of the structure.

Front right hump

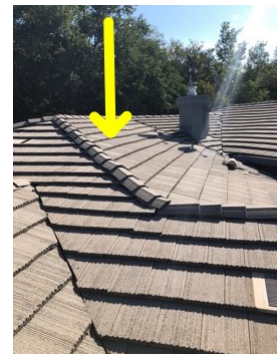
Rear roof waviness

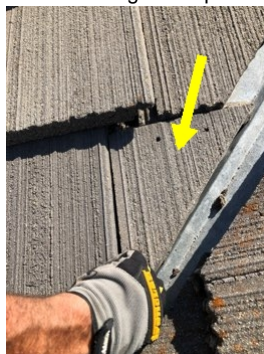
1.4. One or more roof tiles were found to be out of place. Recommend a qualified roofing contractor check for others and reposition/secure as needed.

Loose valley tile

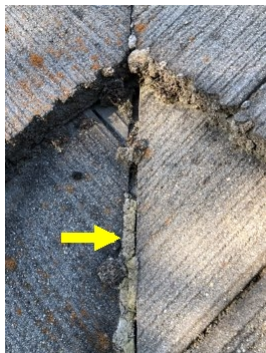
2.1. Clogged valley flashing noted which is meant to direct water into a gutter. Recommend unclogging and further investigation for moisture intrusion.

Moss clogging valley flashing

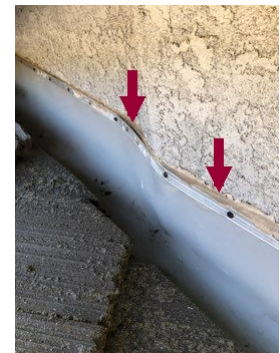
2.2. Questionable sidewall flashing noted with flashing on top of stucco with screws and caulking as opposed to underneath as is preferred. Recommend checking with seller for details and consulting with a qualified contractor for further review and remediation options. Since these types of sealants will normally last 5 years at best, if nothing is done we recommend monitoring for future leaks.

Questionable sidewall flashing

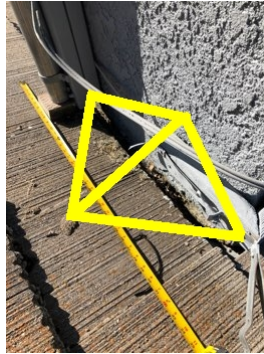
4.4. No "Chimney" was installed above chimney to divert rain water which would now be considered mandatory in new construction. Consequently it is advisable to keep area clean of any accumulated debris which will cause rust and eventual leaks.

Missing cricket to divert water

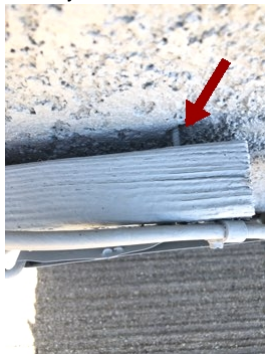
4.6. Satellite dish support frame noted to be separating from stucco chimney enclosure. Recommend consulting with a qualified contractor for remediation options.

Separating satellite wooden support

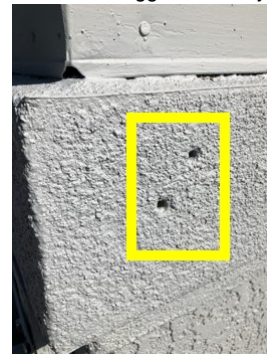
4.7. Open stucco penetration(s) noted. Recommend sealing to avoid moisture intrusion.

Unsealed chimney 2 holes

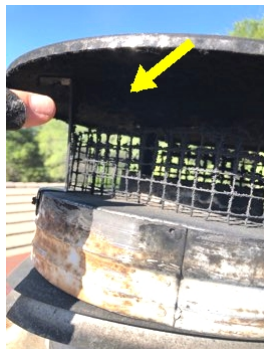
5.1. Spark arrestor screen gap(s) over 1/2" noted which violates California Building Code-Section 3102.3.8 which states; "Openings shall not permit passage of spheres having a diameter larger than 1/2" and shall not block the passage of spheres having a diameter of less than 3/8". Recommend replacing with a proper spark arrestor screen.

Large gap in spark arrestor

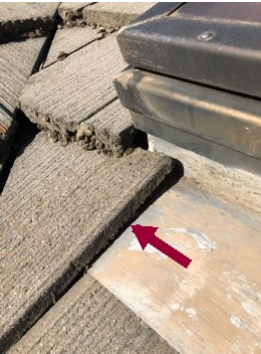
6.1. Roof tile noted over bottom flashing (which should be under) restricting path of rain water and increasing chances of leaking. Recommend consulting with a qualified roofing contractor for remediation options.

Skylight flashing under tile

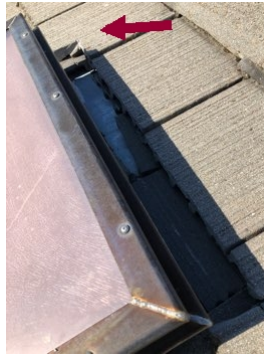
Loose tile above skylight

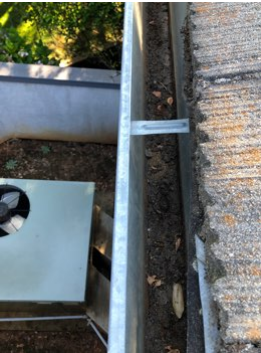
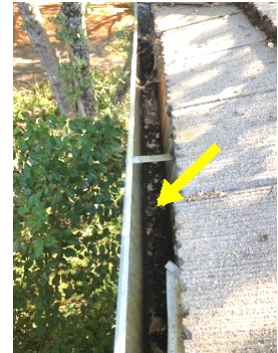
7.1. Gutters with organic materials were noted. Recommend cleaning to avoid downspout clogging and premature gutter deterioration. Consider adding gutter screens to avoid future problems.

Organic material in gutter

Gutter clogged with organic material

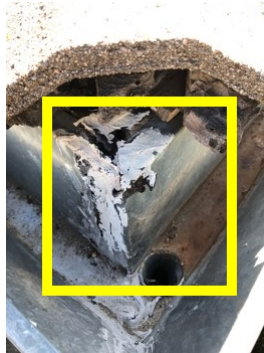
7.2. Newly caulked gutter seam(s) noted. Normally if one seam fails others are close behind so we recommend checking with seller on extent of the repairs and if necessary monitoring for future leaks.

Rear right gutter seam caulk seal

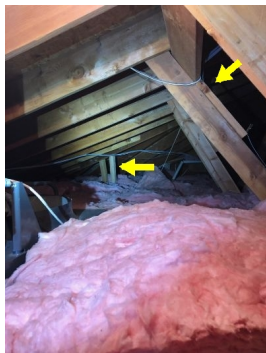
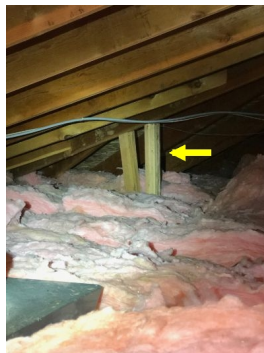
2.3. Questionable construction noted in the form of additional bracing and because of its structural significance considering the weight of a tile roof, this type of work would require a knowledge of load capacities, approved plans and final inspection sign-offs. Recommend checking with seller for such and if necessary, consulting a qualified contractor or structural engineer for further review.

Questionable rafter support

Questionable rafter support close-up

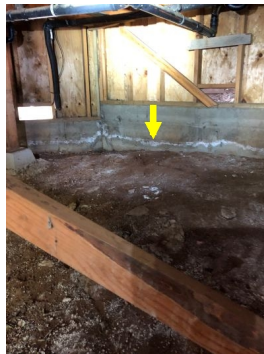
3.1. **Efflorescence** was noted on foundation walls which would indicate water intrusion to some degree. Recommend all Home Inspection Report measures to channel water away from foundation (see notations under: "Grounds > Grading").

Efflorescence on foundation wall

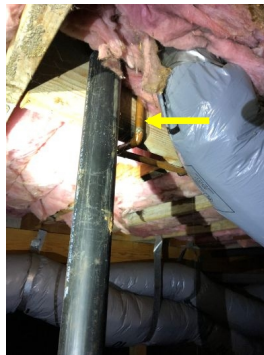
10.3. Missing or deficient unheated area pipe insulation noted. Recommend repair or adding as needed.

Missing copper pipe insulation

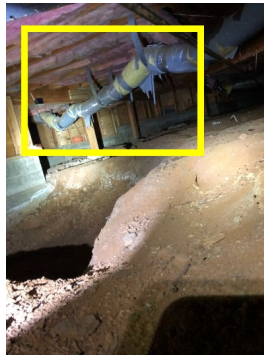
Torn duct pipe vapor barrier

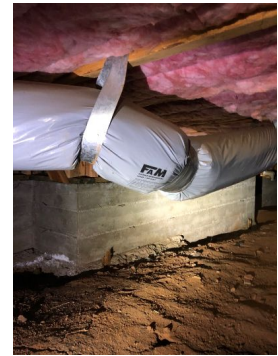
Restrictive duct pipe strapping

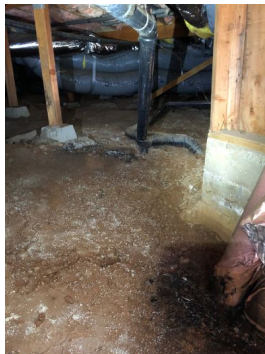
14.1. Areas of crawlspace soil noted as damp at time of inspection. Recommend all actions to minimize foundation area water intrusion (see "Grounds > Grading" and "Roof > Downspouts").

Damp crawlspace soil

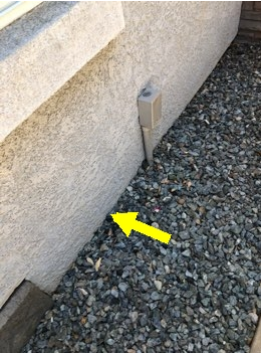
Weep screed covered on right side

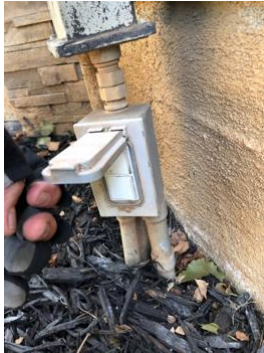
8.1. NOTE: One or more wall switch functionalities were not identified and therefore not inspected. Recommend checking with seller to identify usage and confirm serviceability.

Unknown rear right

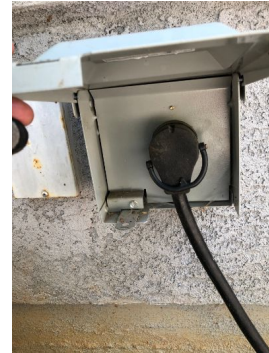
8.2. NOTE: One or more outlets blocked and not accessible. Recommend checking when clear.

Untested outlet near RV parking

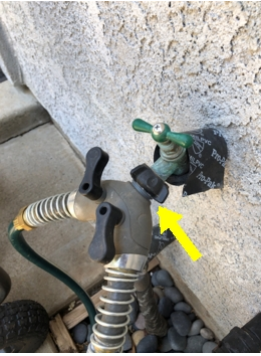
10.1. Anti-siphon hose bibb vacuum breakers not present on outdoor faucets. Most likely not required when home was built, they would now be required for new construction. Although you would be under no obligation to do so, consider adding for safety.

Hose bibb without vacuum breaker

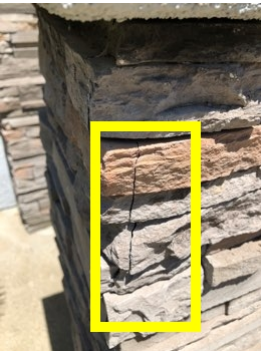
11.3. Masonry column cladding crack(s) noted. Recommend sealing to avoid water intrusion and damage caused by the winter freeze/thaw cycle.

Deck railing stone column cracking

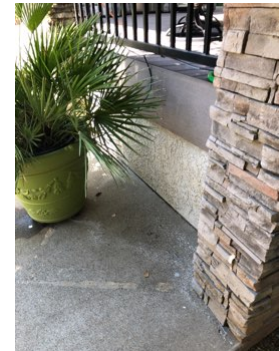
11.2. NOTE: Some deck areas where blocked or out-of-reach and not accessible for a visible inspection including joist, beam and post connections.

No access under deck

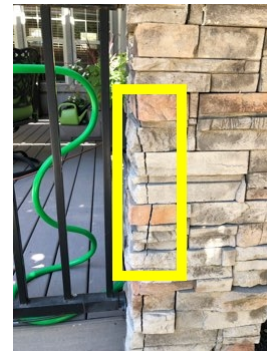
12.1. Masonry column cladding crack(s) noted. Recommend sealing to avoid water intrusion and damage caused by the winter freeze/thaw cycle.

Deck railing stone column cracking

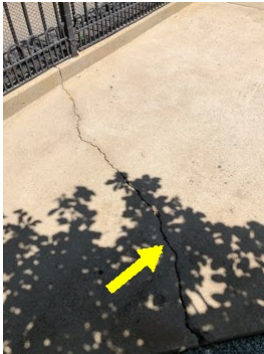
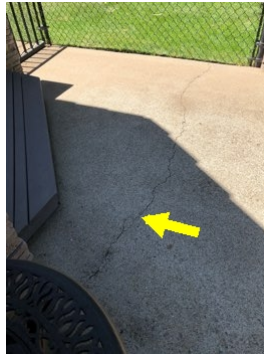
13.1. Moderate cracking was observed in concrete. Further deterioration will occur as water expands and contracts

from freeze and thaw cycles and some may become trip hazards as well. Recommend sealing the cracks, continued monitoring and consulting a qualified contractor for remediation options should condition worsen.

Right side patio cracking

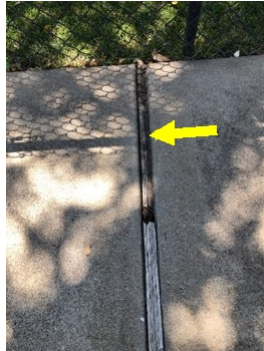
Wood decay on right patio expansion joint

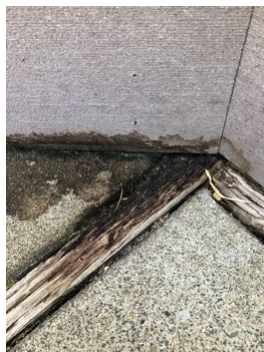
14.1. Moisture staining with early stages of wood decay noted. Recommend eliminating water source.

Right side landing moisture damage

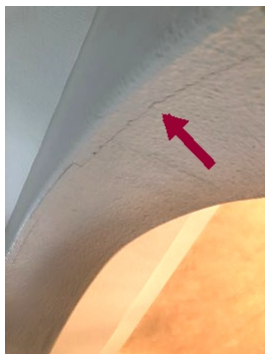
4.1. **Sheetrock crack(s)** noted which normally represents a cosmetic issue as opposed to a structural problem. Consider patching with a flexible caulking to reduce or eliminate eyesore.

Dining archway cracking

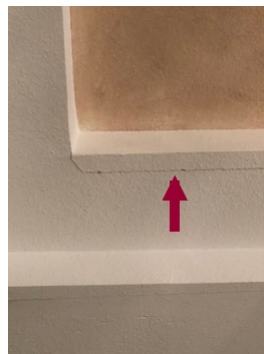
Dining room ceiling crack

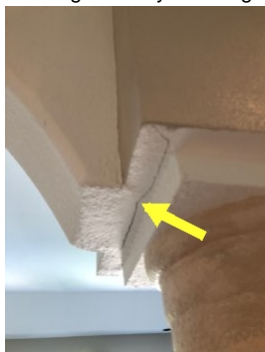
Left living room column crack

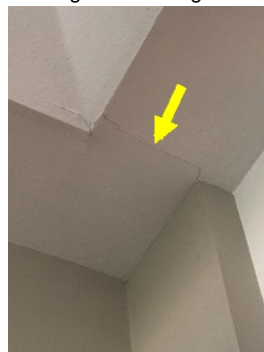
Living room ceiling crack

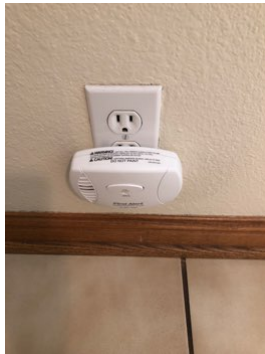
6.3. Inspector did not locate CO alarm(s) in the immediate vicinity of left bedroom(s) which could represent a safety hazard and code violation. Because they may not be easily spotted or readily accessible, we recommend checking with seller for confirmation and if missing, immediately adding as needed for safety.

Hallway CO alarm detail

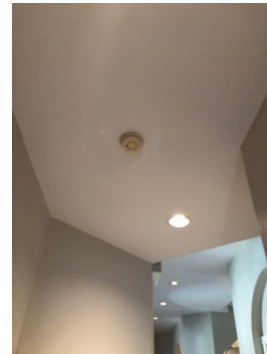
6.2. Inspector did not locate smoke alarm(s) in the immediate vicinity of right bedroom(s) which could represent a safety hazard and code violation. Because they may not be easily spotted or readily accessible, we recommend checking with seller for confirmation and if missing, immediately adding as needed for safety.

Left hallway smoke alarm detail

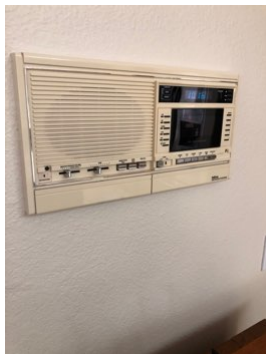
7.1. NOTE: An intercom system was noted with speaker boxes and main control panel. Since testing this system is beyond the scope of this inspection, it is recommended the buyer seek operation guidance from the seller and if necessary, that a qualified professional check the system for serviceability.

Intercom system control panel

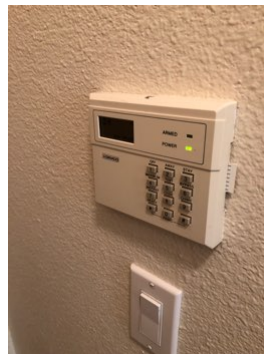
7.2. NOTE: A security system was noted with wall sensors, ceiling alarms and a control panel. Since testing this system is beyond the scope of this inspection, it is recommended the buyer seek operation guidance from the seller and if necessary, that a qualified professional check the system for serviceability.

Security system control pad detail

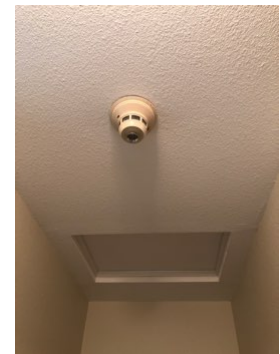
Security system smoke/CO alarm sensor

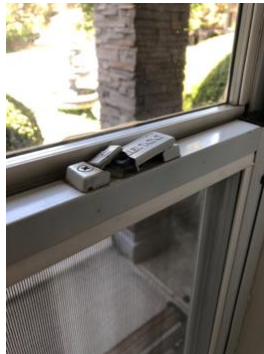
9.4. Broken latch on window(s) noted. Recommend repairs or replacement as needed.

Living room window broken latch

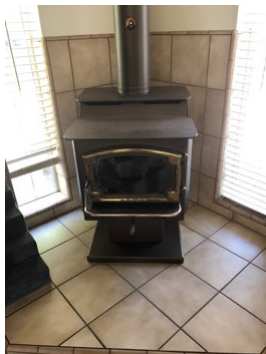
Wood stove detail

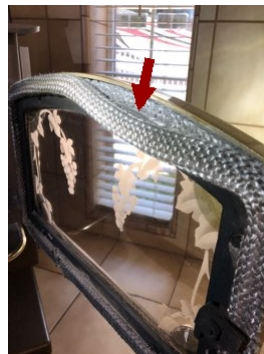
14.2. Wood stove door gasket was noted as deficient or missing which can allow CO gases into the living space. Recommend replacement as needed.

Deficient wood stove door gasket

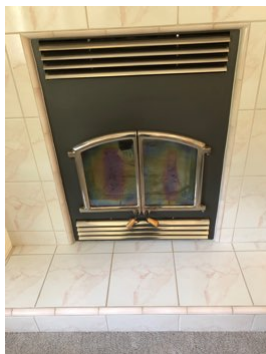
14.4. Fireplace hearth, wall or mantel deficiency noted. Recommend repairs as needed.

Living room fireplace detail

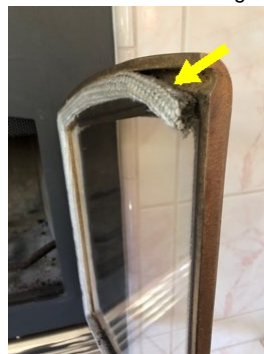
Deficient door gasket

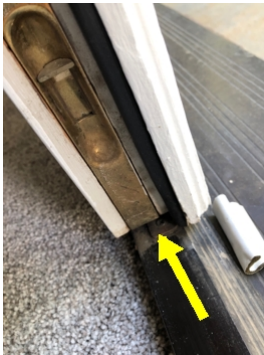
18.2. Inactive part of double door could not be fully latched and/or opened for reasons unknown. Recommend consulting with a qualified contractor for remediation options.

Living room inactive door would not open

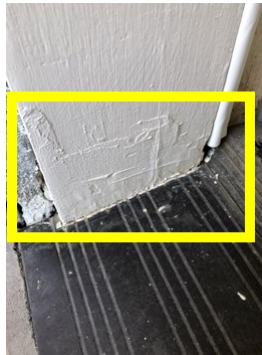
18.3. Damage to door jamb and/or threshold noted. Recommend repairs as needed.

Patched door jamb bottom

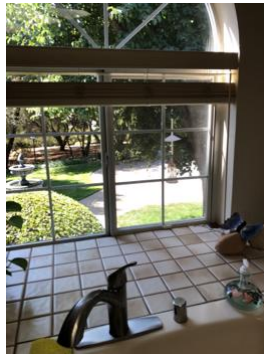
3.1. Window(s) noted to be difficult to open for reasons unknown. Recommend cleaning and lubricating friction points or consulting a qualified window repair contractor for remediation options.

Difficult to open window

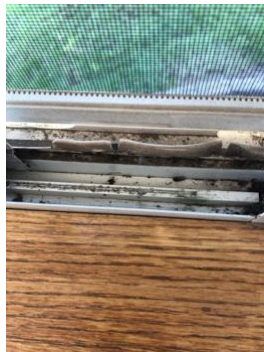
4.1. Screen noted to be damaged on window(s). Recommend repairing or replacing as needed.

Cracked window screen seal

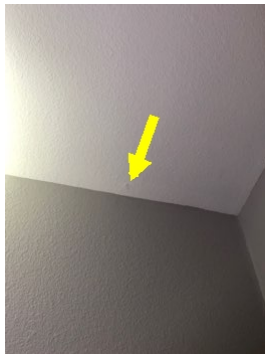
3.1. Popping sheetrock nail heads noted. Recommend repairs as needed.

Ceiling nail pop

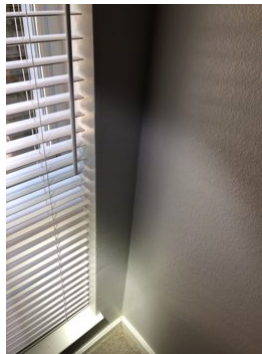
3.2. Patched area(s) of sheetrock noted with reason undetermined. Recommend checking with seller for further details.

Wall corner patch

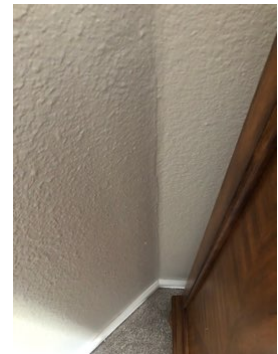
Wall corner patch

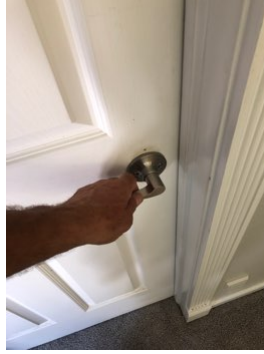
8.2. Door would not latch closed. Recommend repair as needed.

Deficient door latch

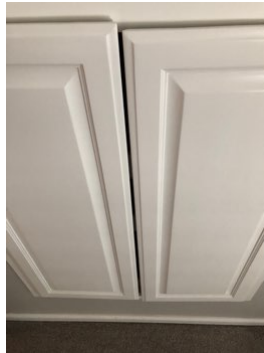
9.1. Misaligned cabinet door(s) noted being prevented from closing properly. Recommend adjustments as needed to close without sticking.

Misaligned doors under TV

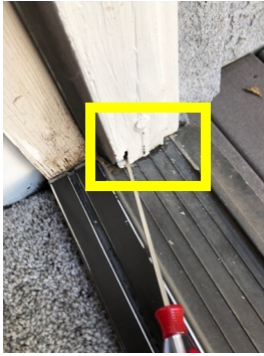
14.1. Lower door jamb wood decay noted. Refer to pest report for more detail and consider consulting a qualified contractor for remediation options.

Door jamb wood decay

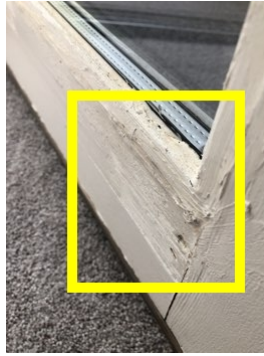
Door frame damage

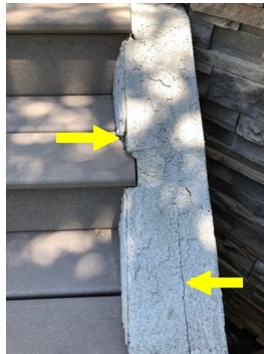
17.2. Cracking stucco stair stringer stucco cap noted. Recommend repairs as needed.

Stair stringer cap stucco cracking

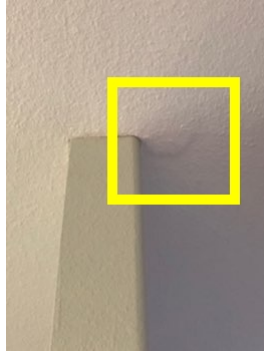
1.1. Unknown sheetrock bulge noted. Recommend checking with seller for further details.

Unknown ceiling bulge above shower

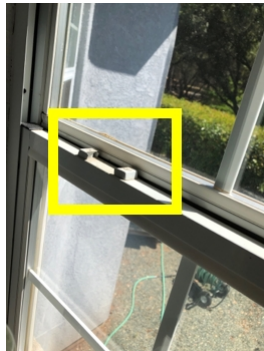
2.2. Broken latch on window(s) noted. Recommend repairs or replacement as needed.

Broken latch in toilet room

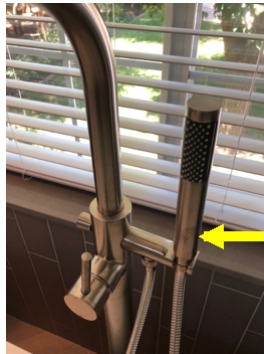
7.3. NOTE: Tub spray wand could not be turned on for reasons unknown. Recommend checking with seller for further detail.

Spray wand not tested

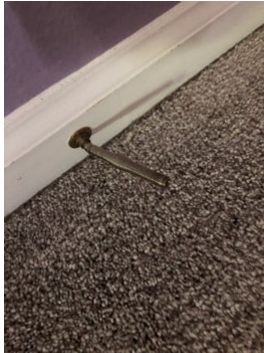
2.1. Missing, poorly adjusted or damaged door stop noted which serves to protect wall or other surfaces from damage. Recommend adding, adjusting or replacing as needed.

Deficient bedroom 3 door stop

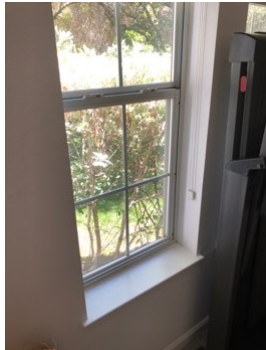
6.2. Broken or weak balance springs noted on window(s). Recommend replacement as needed.

Bedroom 2 broken balance spring

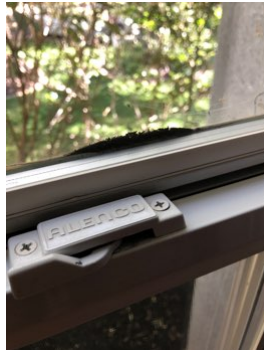
Broken bedroom 3 window latch

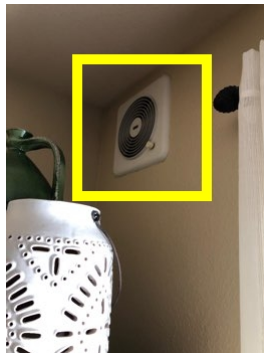
11.2. NOTE: Unknown wall fan was noted but not inspected. Recommend checking with seller for further details.

Unknown bedroom 4 fan

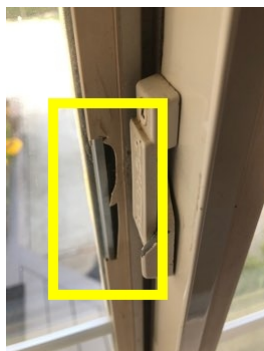
12.1. Damage to door skin or surface noted. Recommend repairs as needed.

Damaged bedroom 4 exterior door

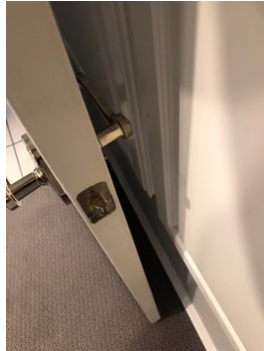
2.1. Missing, poorly adjusted or damaged door stop noted which serves to protect wall or other surfaces from damage. Recommend adding, adjusting or replacing as needed.

Missing half bath door stop

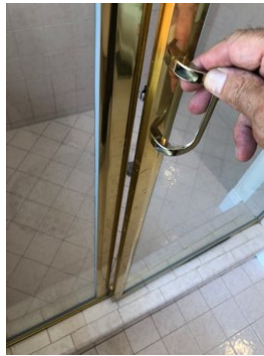
7.1. Bath 2 glass shower door was sticking at bottom and difficult to close. Recommend repairs as needed.

Bath 2 shower door rubs at bottom

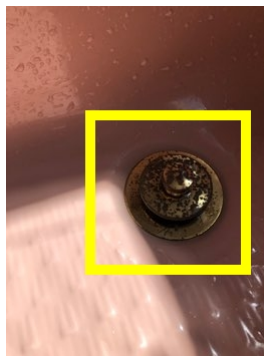
8.1. Worn tub stopper finish noted and it is not known if it can be restored to its original condition.

Worn bath 2 tub stopper

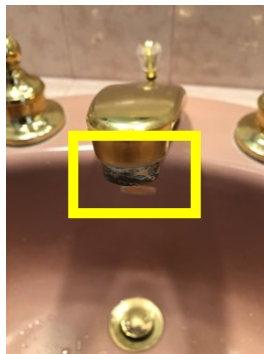
13.2. Sink faucet noted to be corroded at spout. Recommend repair or replacement as needed.

Worn bath 2 faucet finish

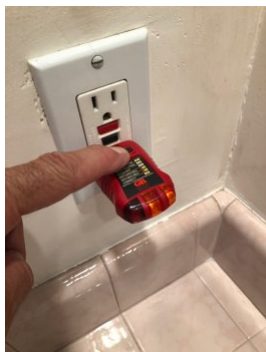
19.1. GFCI did not respond to test with power remaining "on" and is therefore not reliable as a ground fault circuit interrupter. Recommend replacing for safety.

Deficient bath 2 GFCI with power on

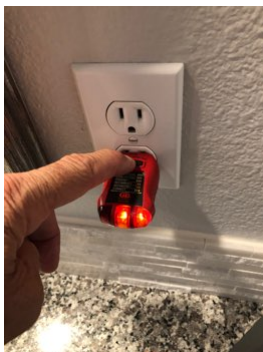
No half bath outlet GFCI protection

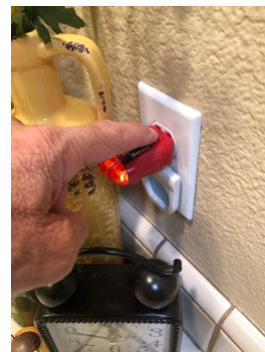
Deficient bath 3 GFCI outlet

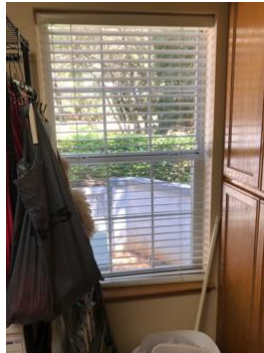
3.1. **NOTE: Window(s) noted to be inaccessible and therefore not inspected. Recommend removing obstacle(s) and inspecting as needed.**

Blocked by faulty blinds

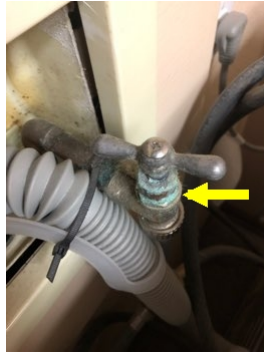
10.1. Water angle stop noted as worn or leaking. Recommend a qualified plumber replace with a quarter-turn angle stop.

Corrosion on washer water valve

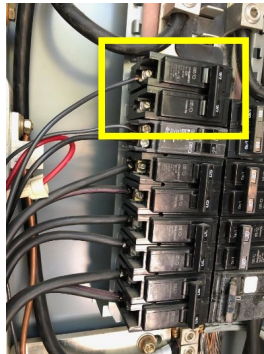
6.1. 2-pole breaker on main breaker box noted to be half loaded (one wire instead of two as intended). The breaker must be able to trip before the wires connected to it can become damaged and a 2-pole breaker only loaded on one half is likely to have too much mechanical resistance to do that which can lead to wire overheating and possible fire danger. Recommend a qualified contractor repair as needed for safety.

Half loaded 2-pole breaker in main breaker box

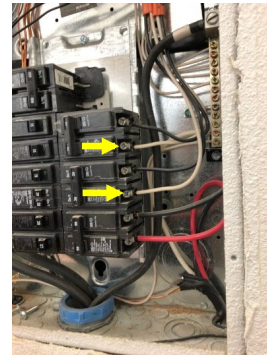
7.1. Unmarked **white wire** used as hot conductor which is not an appropriate and would be considered unsafe to someone working on the electrical system of this house. Recommend re-identification to black or red as needed for safety.

Unmarked white wire on sub panel

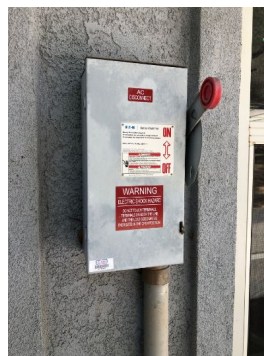
9.1. NOTE: Auxiliary generator and/or switch box noted but not inspected. Recommend confirming serviceability and if necessary a full evaluation by a qualified electrician.

Main disconnect possibly for generator use

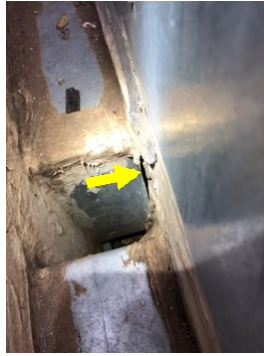
6.1. Deficient plenum seal noted which will allow rain penetration and vermin intrusion. Recommend sealing as needed.

Deficient plenum seal

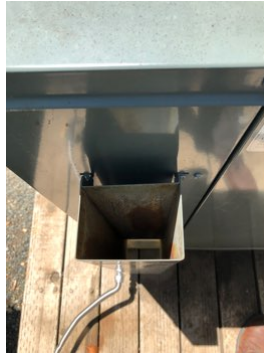
7.1. Exterior HVAC unit exhaust vent noted to be missing screen which could allow for vermin intrusion. Recommend adding an appropriate screen as needed.

Missing exterior vent screen

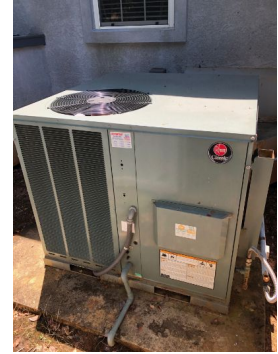
HVAC heating & cooling unit detail

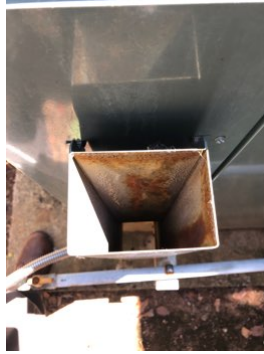
7.1. Exterior HVAC unit exhaust vent noted to be missing screen which could allow for vermin intrusion. Recommend adding an appropriate screen as needed.

No exterior vent screen

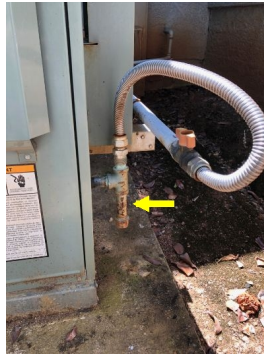
9.1. Sediment trap was in place and appeared serviceable at time of inspection.

Gas line with sediment trap

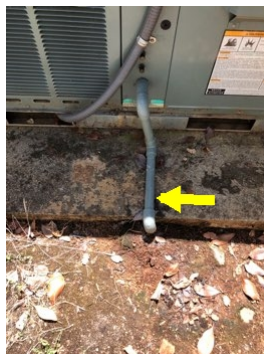
10.1. Condensate drain line water trap noted to be broken, deficient or missing. Recommend repairs or replacement as needed by a qualified HVAC contractor.

Missing trap on condensate drain line

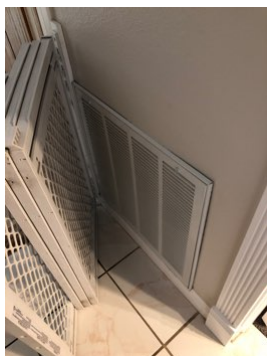
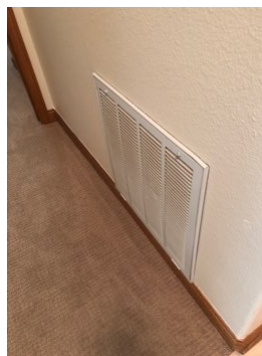
11.1. No HVAC filter or grille problems or concerns noted at time of inspection.

HVAC return air filter detail

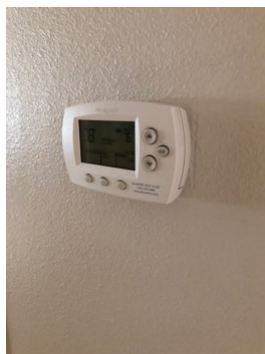
12.1. Although not exhaustive as to the various settings, the digital programmable thermostat(s) appeared functional at time of inspection.

Digital thermostat detail

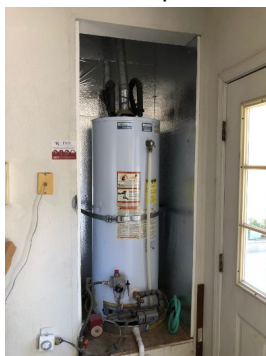
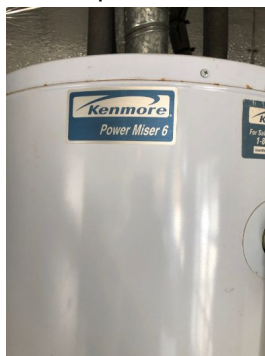
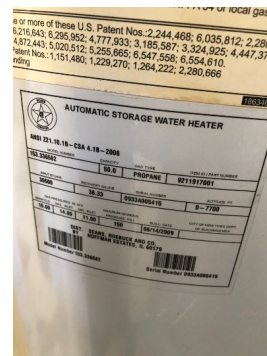
1.1. No water heater problems or concerns at time of inspection other than noted below.

Water heater detail

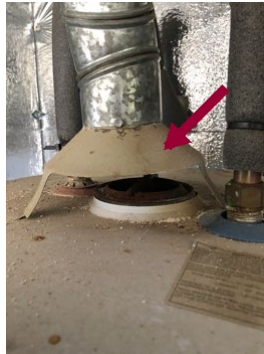
6.1. Flue pipe and gas appliance noted as slightly misaligned and potentially not properly carrying exhaust gases to the exterior. Recommend aligning as needed for safety.

Misaligned vent pipe

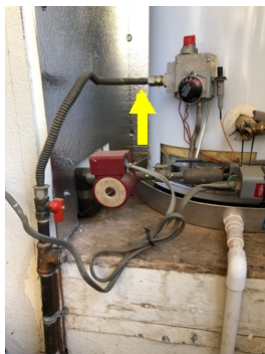
9.1. Sediment trap is missing and most likely not required when this house was built, sediment traps are now required by the Uniform Plumbing Code and are therefore incorporated into most, if not all, city building and safety codes. Although you would be under no obligation to do so, consider adding to increase appliance longevity.

Gas line without sediment trap

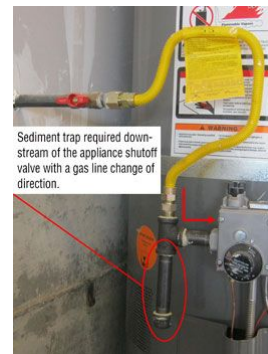
Example of gas line sediment trap

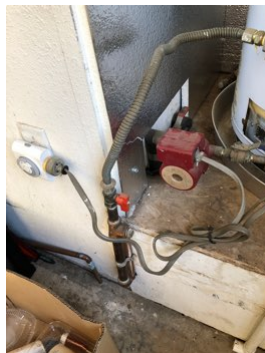
13.1. Although not confirmed to be recirculating hot water as intended, the recirculating pump was noted to be running with no leaks detected.

Recirculating pump detail

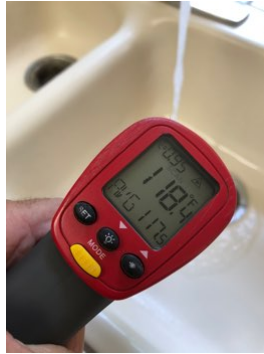
14.1. **Water temperature** is 118.4° as measured at the kitchen sink.

Kitchen sink water temperature

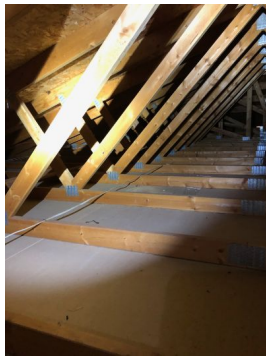
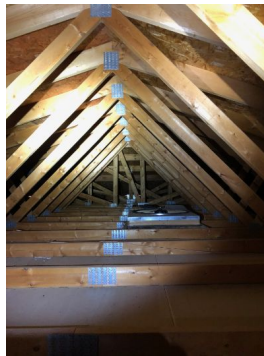
1.1. No problems or concerns noted at time of inspection with the visibly accessible **engineered wood** roof truss system.

Attached garage attic detail

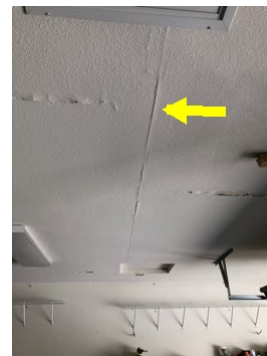
2.1. Area of sheetrock joint tape noted as lifting and cracking and some sheetrock surface damage noted. Recommend repairs as needed.

Lifting seam tape

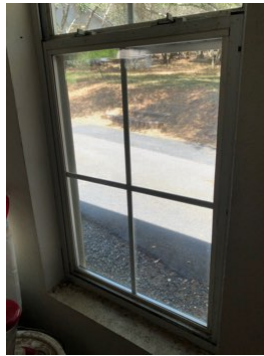
4.2. Broken or weak balance springs noted on window(s). Recommend replacement as needed.

Broken balance spring

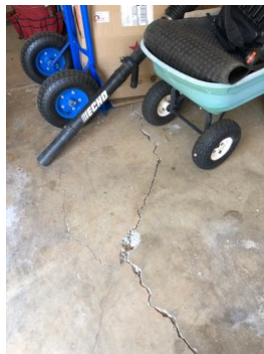
6.1. Large crack(s) noted in concrete garage floor. Recommend sealing, continued monitoring and consulting a qualified contractor for remediation options should conditions dramatically change.

Significant concrete floor cracking

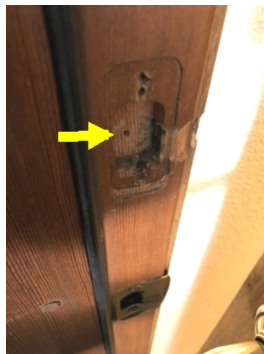
7.2. Missing strike plate noted allowing closed door to move in and out. Recommend adding as needed.

Missing strike plate

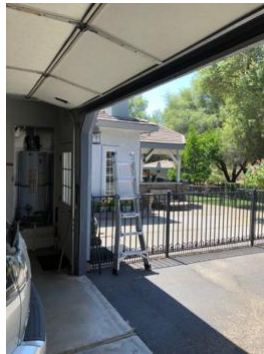
10.2. Auto-reverse feature on double-car vehicle door noted as not present or not adjusted properly and either not reversing at all or requiring too much resistance to reverse. This is a serious safety concern for small children and animals and we recommend immediate remediation as necessary for safety

Deficient large door auto-reverse

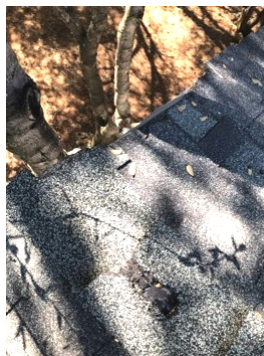
1.2. Damaged shingle(s) noted on roof. Recommend a qualified roofing contractor repair or replace as needed.

Right side tree branch roof damage

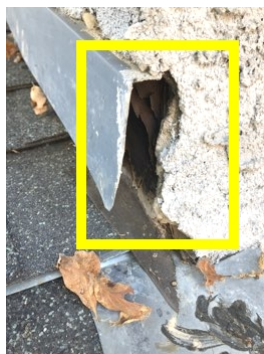
2.2. Deficient front sidewall base flashing termination with large unsealed gap noted. Recommend sealing as needed to avoid moisture intrusion.

Front gap in flashing

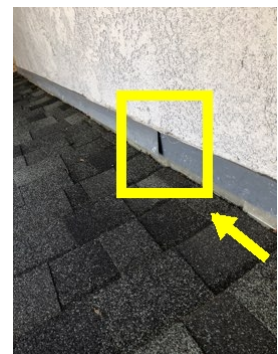
2.3. Sidewall base flashing noted to be stepped in wrong direction with downhill section overlapping uphill section. Recommend consulting with a qualified roofing contractor for remediation options.

Wrong overlap on stucco sidewall flashing

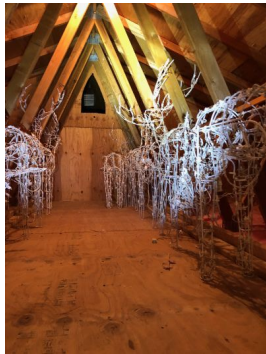
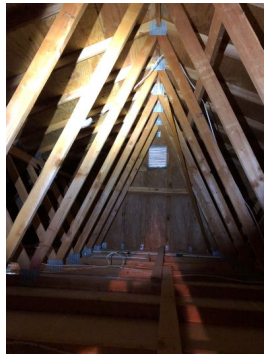
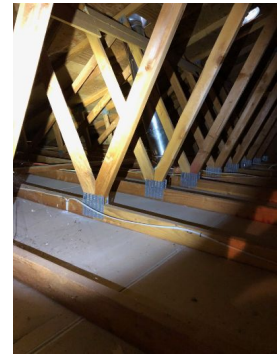
5.1. No problems or concerns noted at time of inspection with the visibly accessible engineered wood roof truss system.

Detached garage attic detail

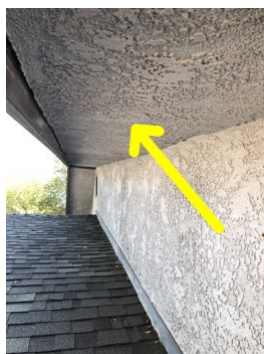
6.1. Eave area soffit board missing with stucco and lath noted to be attached only to rafter blocking and tails which is not best practice. This has already caused stucco breakage, sagging and seam separation from barge rafter. Recommend consulting with a qualified contractor for remediation options.

Sag in eave stucco

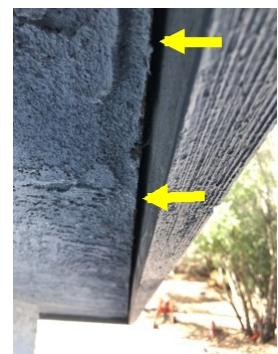
Stucco separation from barge rafter

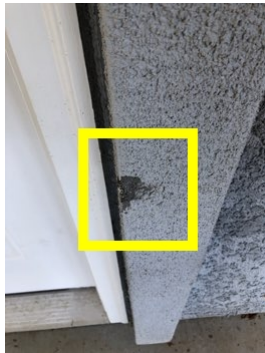
8.1. Damaged trim noted from unknown cause. Recommend repairs as needed.

Left stucco trim damage

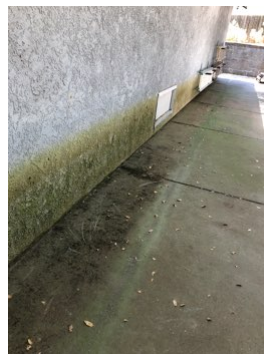
Rear stucco staining

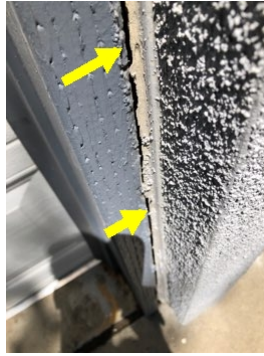
10.1. Poorly sealed **exterior cladding** junctions noted in places. Recommend caulking as needed to avoid moisture intrusion and its related negative effects.

Deficient left vehicle door seal

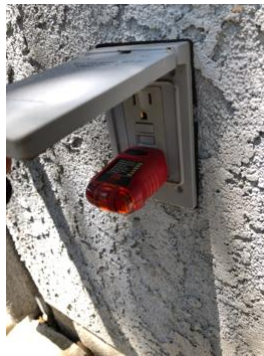
11.1. GFCI without power or would not reset once tripped and is therefore not reliable as a ground fault circuit interrupter. Recommend replacing for safety.

Deficient front right GFCI outlet

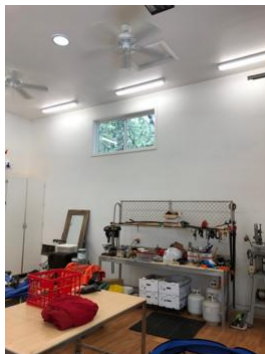
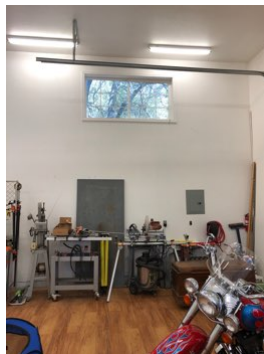
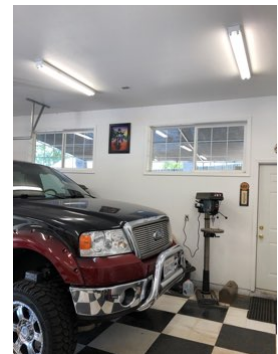
13.1. NOTE: Window(s) noted to be inaccessible and therefore not inspected. Recommend removing obstacle(s) and inspecting as needed.

Unreachable window

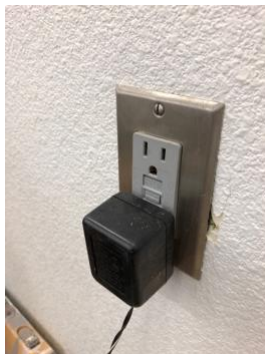
21.1. Installed GFCI outlet protection was tested and appeared operational at time of inspection.

Right GFCI protected outlet

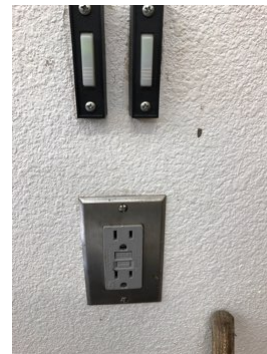
21.2. NOTE: GFCI outlet in this area resets outlet in other areas.

Left GFCI protected outlet

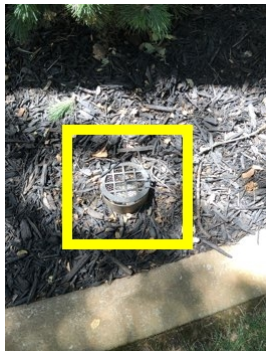
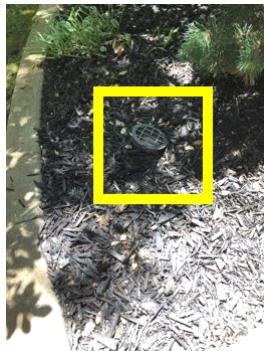
3.2. NOTE: A **lot drainage** system was noted but not inspected. Recommend checking with seller on serviceability.

Front drain grate detail

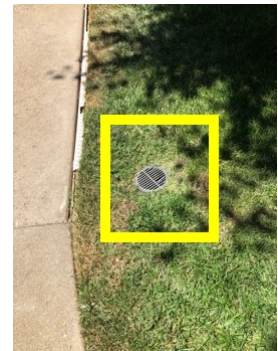
Rear drainage grate detail

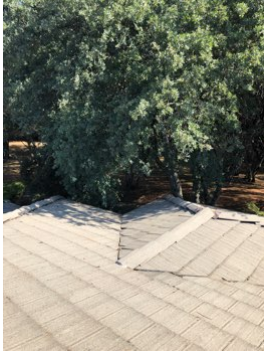
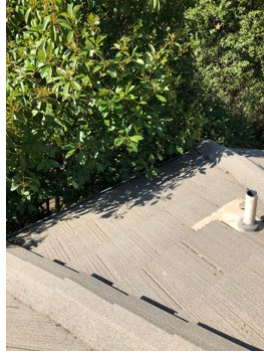
4.1. **Overhanging tree limbs** noted on portions of the roof which can result in roof damage. Recommend a professional tree service trim as needed.

Tree branches overhanging roof deck

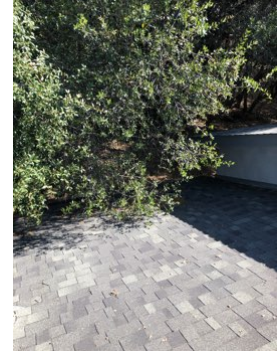
Tree branches overhanging detached garage

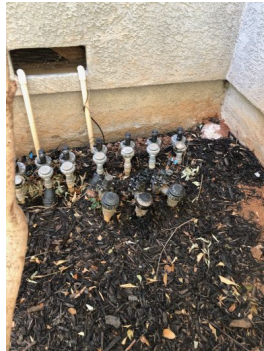
6.1. NOTE: An outdoor irrigation system was noted with sprinkler valves and a control panel. Since testing this system is beyond the scope of this inspection, it is recommended the buyer seek operation guidance from the seller and that a qualified landscaping professional check the system for serviceability.

Irrigation system sprinkler valves
